15 PRESERVATION BRIEFS

Preservation of Historic Concrete

Paul Gaudette and Deborah Slaton

National Park Service
U.S. Department of the Interior
Heritage Preservation Services

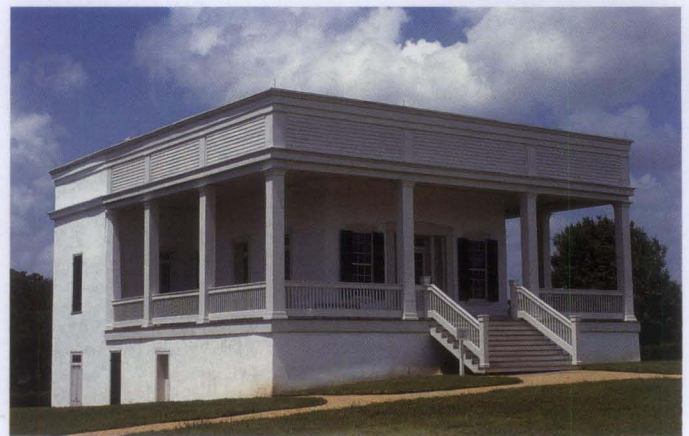
Figure 1. The Sebastopol House in Seguin, Texas, is an 1856 Greek Revival-style house constructed of lime concrete. Lime concrete or "limecrete" was a popular construction material, as it could be made inexpensively from local materials. By 1900, the town had approximately ninety limecrete structures, twenty of which remain. Photo: Texas Parks and Wildlife Department.

publicized in the second edition of Orson S. Fowler's *A Home for All* (1853) which described the advantages of "gravel wall" construction to a wide audience. The town of Seguin, Texas, thirty-five miles east of San Antonio, already had a number of concrete buildings by the 1850s and came to be called "The Mother of Concrete Cities," with approximately ninety concrete buildings made from local "lime water" and gravel (Fig. 1).

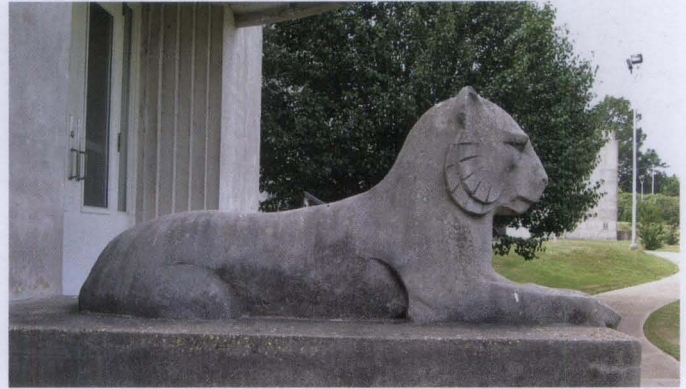
Figure 7. Detailed bas reliefs as well as sculptures, such as this lion at the Bailey Magnet School, could be used as ornamentation on concrete buildings. Sculptural concrete elements were typically cast in molds.

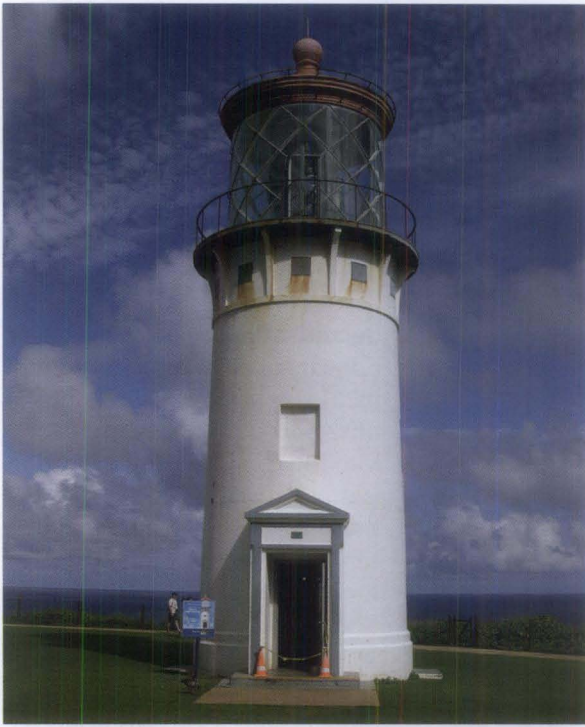
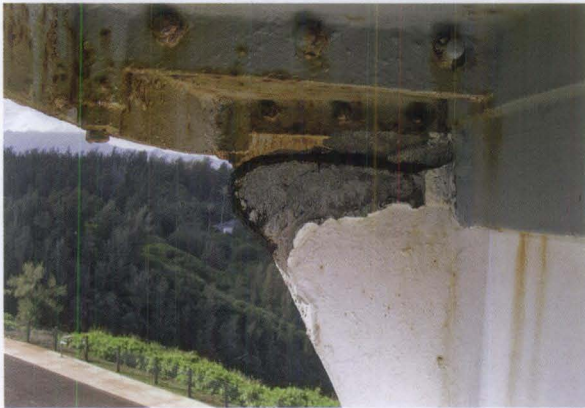
Figure 12. The concrete lighthouse at the Kilauea Point Light Station, Kilauea, Kauai, Hawaii, was constructed circa 1913. The concrete, which was a good quality, high strength mix for its day, is in good condition after almost one hundred years in service. Deterioration in the form of spalling related to corrosion of embedded reinforcing steel has occurred primarily in areas of higher ornamentation such as projecting bands and brackets (see close-up photo).

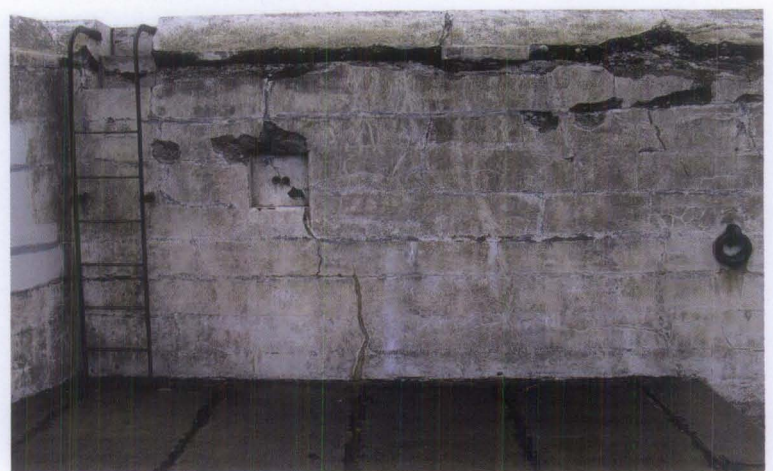
Figure 13. Fort Casey on Admiralty Head, Fort Casey, Washington, was constructed in 1898. The lift lines from placement of concrete are clearly visible on the exterior walls and characterize the finished appearance.

In concrete structures built prior to the First World War, concrete was often placed into forms in relatively short vertical lifts due to limitations in lifting and pouring techniques available at the time. Joints between different concrete placements (often termed cold joints or lift lines) may sometimes be considered an important part of the character of a concrete element (Fig. 13). However, wide joints may permit water to infiltrate the concrete, resulting in more rapid paste erosion or freeze-thaw deterioration of adjacent concrete in cold climates.

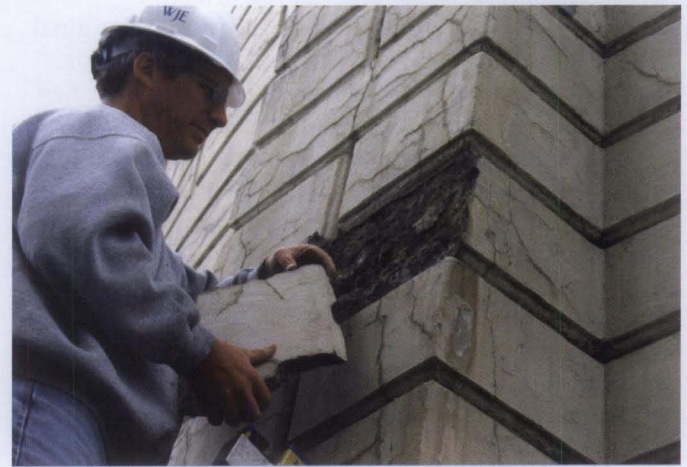
Figures 14. Layers of architectural concrete that have debonded (spalled) from the surface were removed from a historic water tank during the investigation performed to assess existing conditions. Photos: Anita Washko, Wiss, Janney, Elstner Associates, Inc.

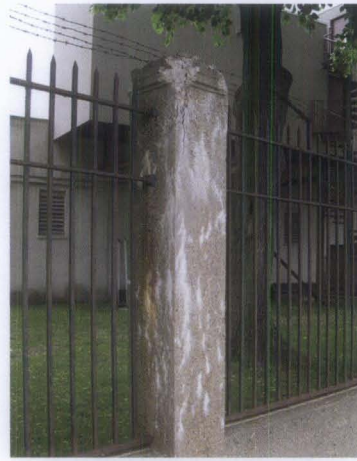
Figure 15. Evidence of moisture movement through concrete is apparent in the form of mineral deposits on the concrete surface. Cyclic freezing and thawing of entrapped moisture, and corrosion of embedded reinforcement, have also contributed to deterioration of the concrete column on this fence at Crocker Field in Fitchburg, Massachusetts, designed by the Olmsted Brothers.

Staining of the concrete surface can be related to soiling from atmospheric pollutants or other contaminants, dirt accumulation, and the presence of organic growth. However, stains can also indicate more serious underlying problems, such as corrosion of embedded reinforcing steel, improper previous surface treatments, alkali-aggregate reaction, or efflorescence, the deposition of soluble salts on the surface of the concrete as a result of water migration (Fig. 15).

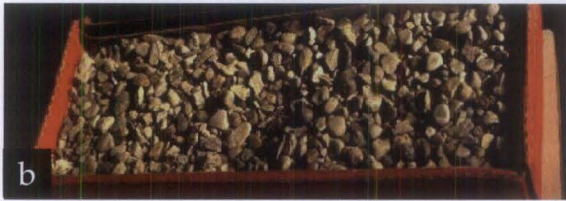
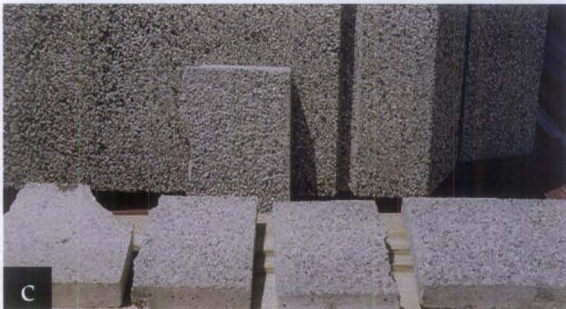
Figure 18. (a) Exposed aggregate precast concrete is sounded with a hammer to detect areas of deterioration. Corrosion of the exposed reinforcing steel bar has led to spalling of the adjacent concrete. (b) Samples of aggregate considered for use in repair concrete are compared to the original concrete materials in terms of size, color, texture, and reflectance. (c) Various sample panels are made using the selected concrete repair mix design for comparison to the original concrete on the building, and the mix design is adjusted based on review of the samples. (d) After removal of the spall, the concrete surface is prepared for installation of a formed patch. (e) Prior to placement of the concrete, a retarding agent is brush-applied to the inside face of the formwork to slow curing at the surface. After the concrete is partially cured, the forms are removed and the surface of the concrete is rubbed to remove some of the paste and expose the aggregate to match the original concrete.

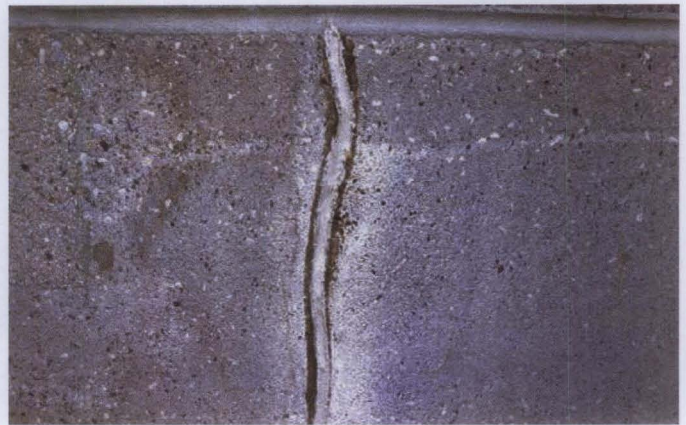
Figure 19. A high-speed grinder is used to widen a crack in preparation for installation of a sealant. This process is called "routing." After the crack is prepared, the sealant is installed to prevent moisture infiltration through the crack. Although sealant repairs can provide a durable, watertight repair for moving cracks, they tend to be very visible.

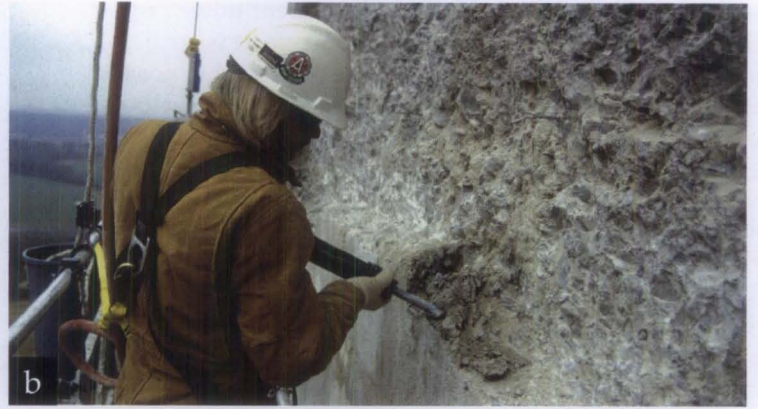
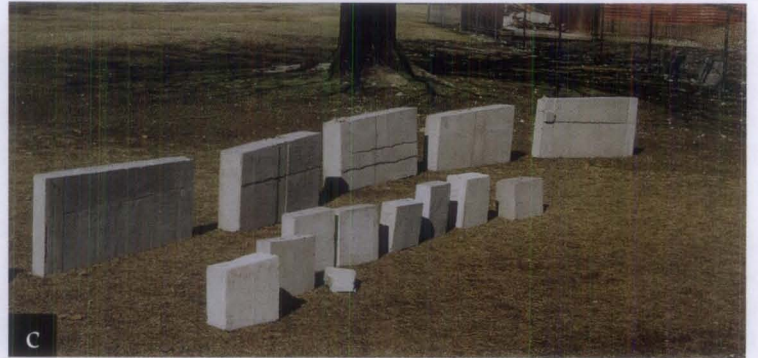
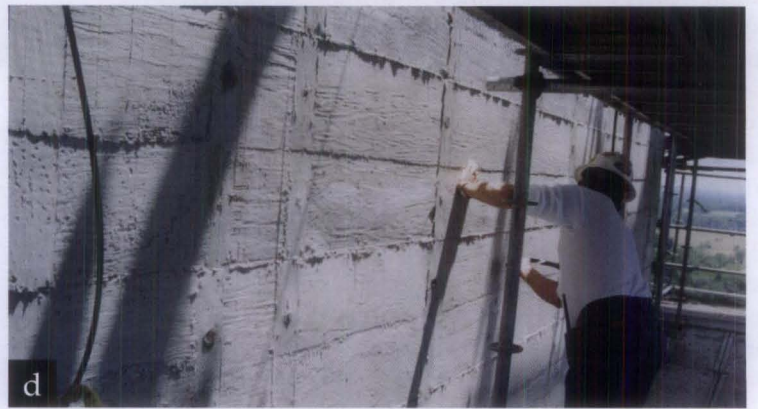
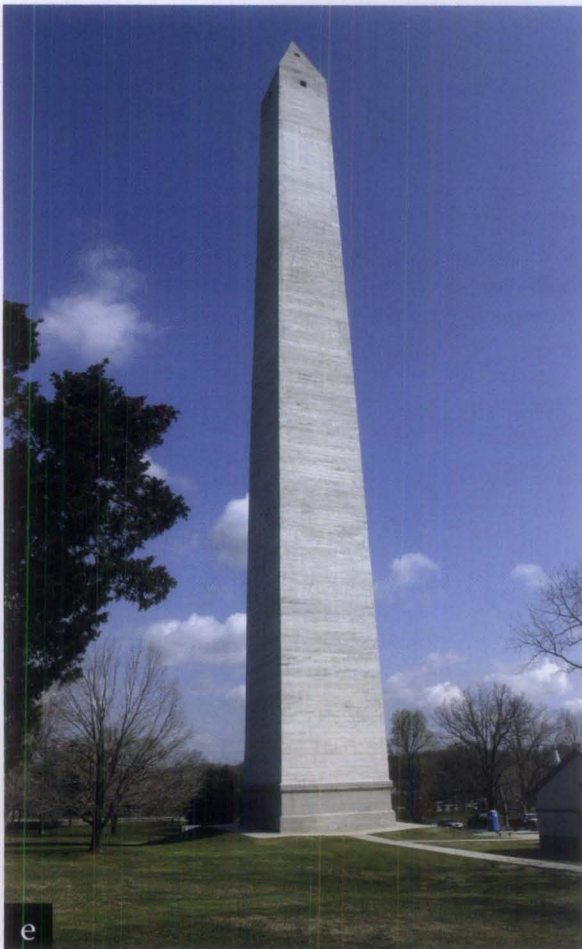
Figure 20. (a) The Jefferson Davis Memorial in Fairview, Kentucky, constructed from 1917–1924, is 351 feet tall and constructed of unreinforced concrete. The walls of the memorial are 8 feet thick at the base and 2 feet thick at the top of the wall. Access to the monument for investigation was provided by rappelling techniques, while ground supported and suspended scaffolding was used to access the exterior during repairs. (b) The concrete was severely deteriorated at isolated locations, with spalling and damage from cyclic freezing and thawing of entrapped water. In addition, previous repairs were at the end of their service life and removal of deteriorated concrete and failed previous repairs was required. Light duty chipping hammers were used to avoid damage to adjacent material when removing deteriorated concrete to the level of sound concrete. (c) Field samples were performed to match the color, finish, and texture of the original concrete. A challenge in matching of historic concrete is achieving variability of appearance. (d) The completed surface after repairs exhibits intentional variability of the concrete surface to match the appearance of the original concrete. Some formwork imperfections that would normally be removed by finishing were intentionally left in place, to replicate the highly variable finish of the original concrete. (e) The Jefferson Davis Memorial after completion of repairs in 2004. Photo e: Joseph Lenzi, Senler, Campbell & Associates, Inc.

due to original construction techniques, architectural design, or differential exposure to weather. Trial repairs and mock-ups are used to evaluate the proposed replacement concrete work and to refine construction techniques (Fig 20).
