Harry Carey Ranch (Clougherty Ranch)
28515 San Francisquito Canyon Road
Saugus
Los Angeles County
California

HABS No. CA-2712

**Historic American Buildings Survey
National Park Service
Western Region
Department of the Interior
San Francisco, California 94107**

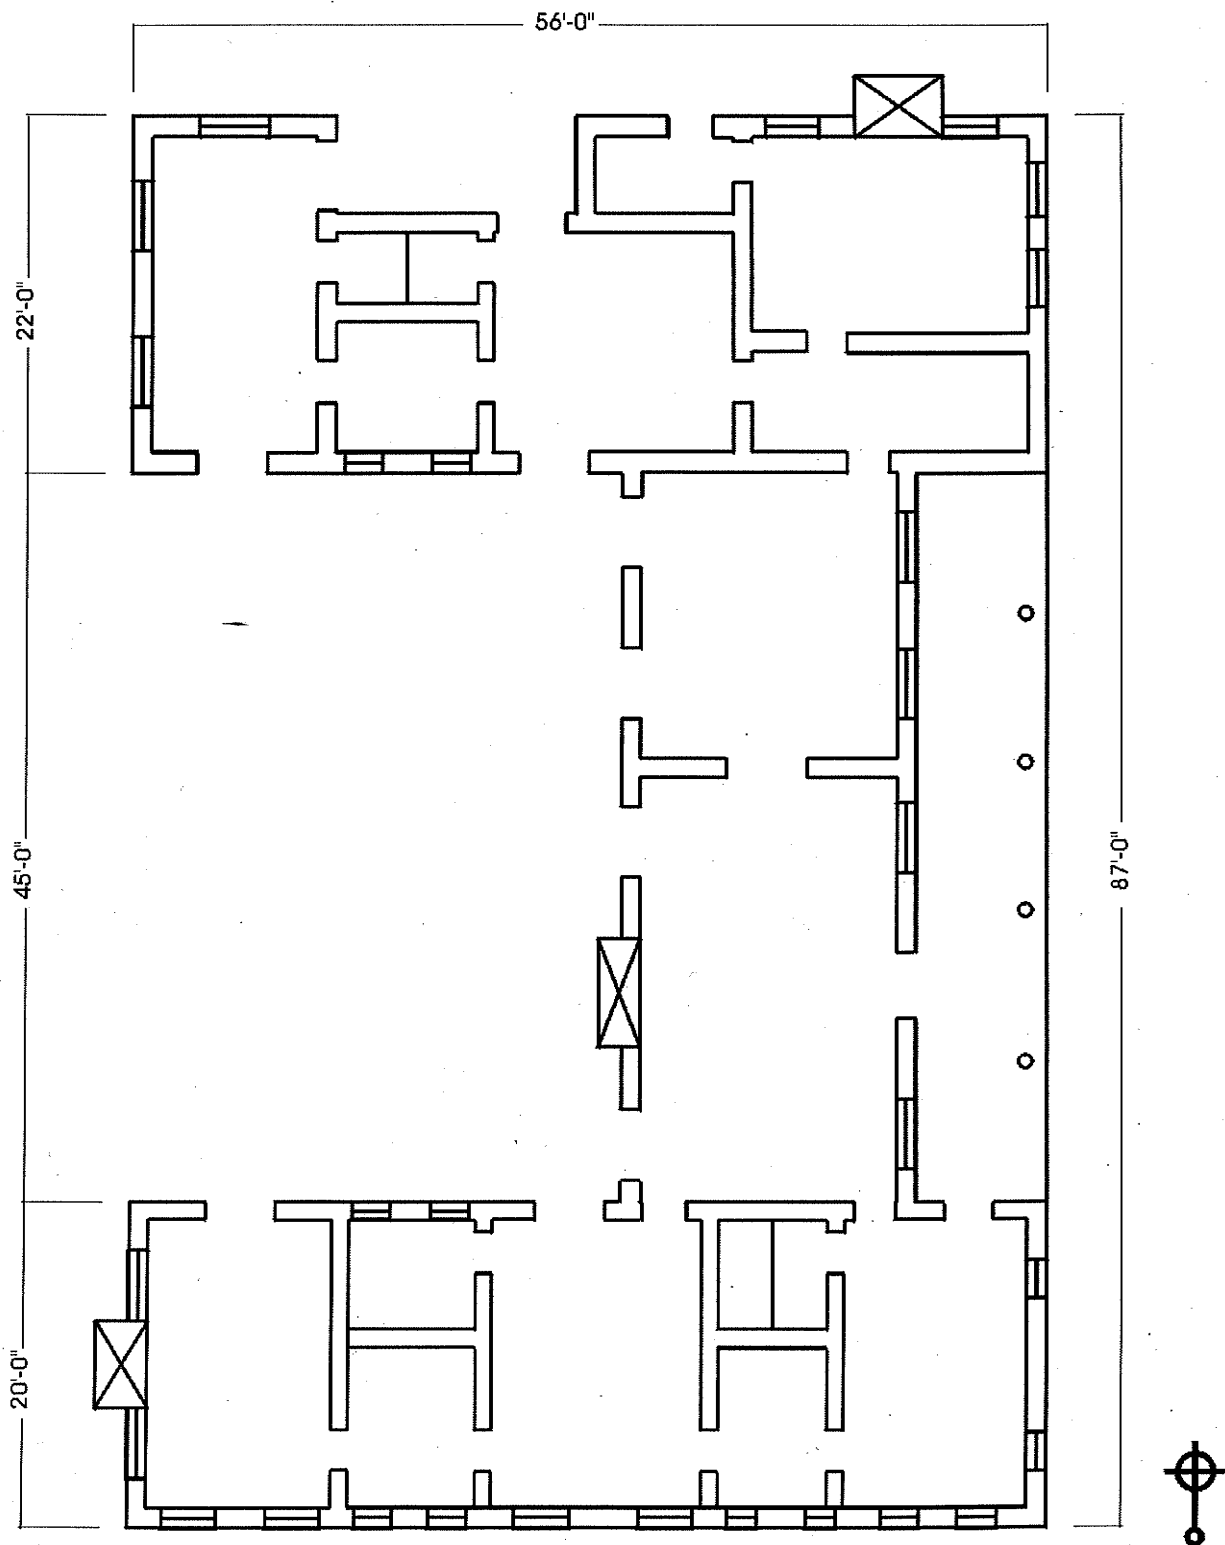
Figure 3. Main House (Building 5)

1. Overall dimensions: This U-shaped residence measures about 87'- 0" along the façade, which includes the 45'- 0" long porch, the width of the south wing (20'- 0") and the north wing (22'- 0"). Each wing is about 56'- 0" long. A recessed uncovered porch is set into the north side of the northern wing (see Sketch Plan).
2. Foundations: The house appears to rest on a poured concrete perimeter foundation, but because the interior floor levels are uneven, its exact construction type is unknown. A small cellar is located under the kitchen and is accessed by a trap door in the floor.

1. Floor plans: Private rooms (bedrooms and baths) are located within the south and north wings, while the public areas (living room, dining room, and kitchen) are found within the central section. Generally, access to all rooms is via another room; the only hallway in the house is a short space between the dining room and the kitchen that also opens onto the first bedroom of the north wing. The house contains five rooms used as bedrooms and three baths (two bedrooms on west end of each wing are divided by a shared bathroom). Three fireplaces appear in each of the major portions of the house except the north bedroom wing. Most of the major rooms are also accessed via the courtyard except for the bathrooms, kitchen and easternmost bedroom on the southern wing. All interior walls are adobe (1'-2" wide); most are finished in concrete plaster and paint.

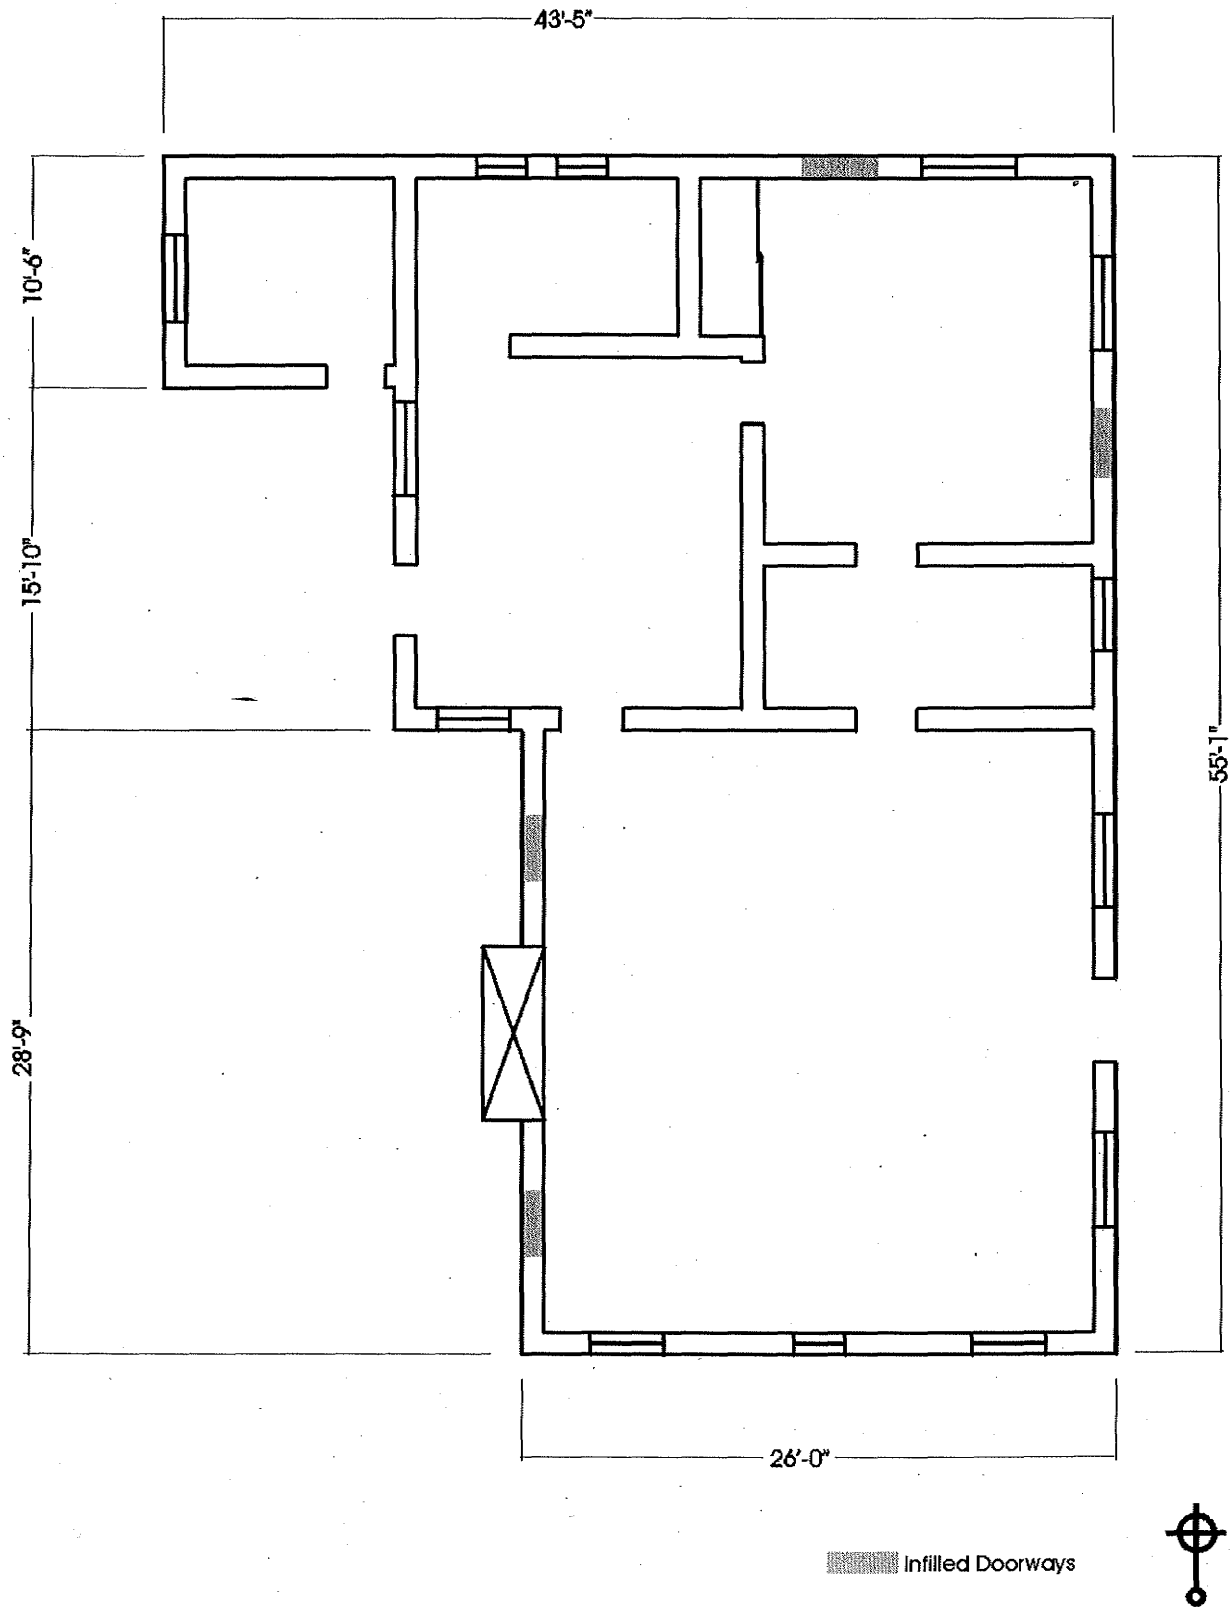
Figure 4. Caretaker's House (Building 9A)

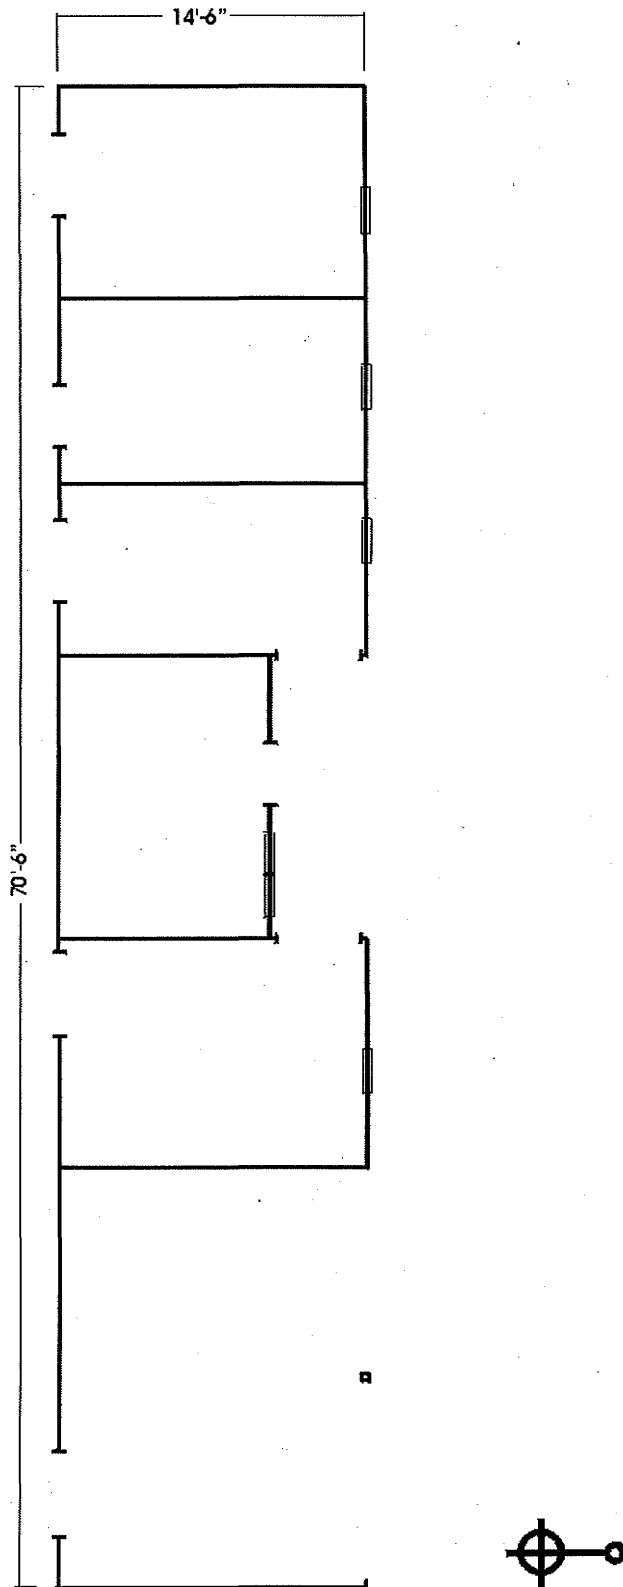
Figure 5. Wood Stable (Building 8)
