The 1928 St. Francis Dam Failure and Its Impact on American Civil Engineering

J. David Rogers

THE 1928 ST. FRANCIS DAM DISASTER

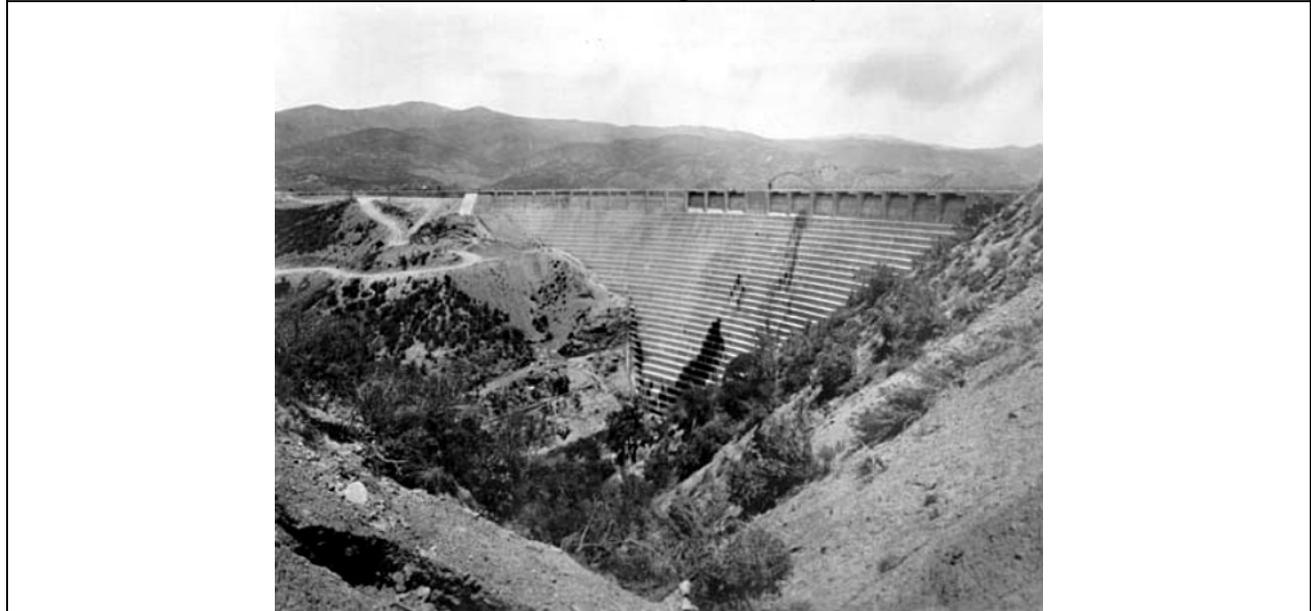
Figure 2 – St. Francis Dam as viewed from the old road, from the left abutment. The old access road with the 18% grade can be seen climbing the right abutment, below the dike. This was where the ‘muddy water’ was observed by damkeeper Harnishfaeger on the morning of the failure. Also note how it would be difficult to notice people with flashlights at the base of the dam’s left abutment, which cannot be seen from the old road.

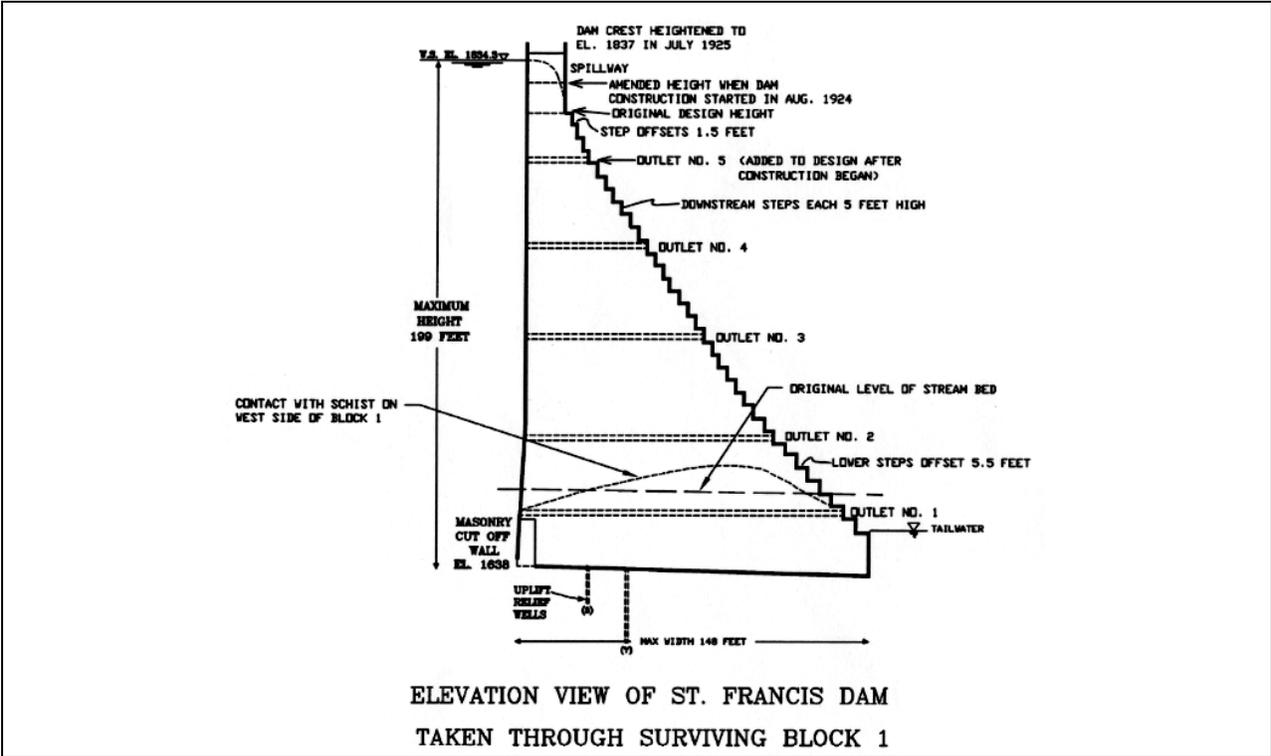
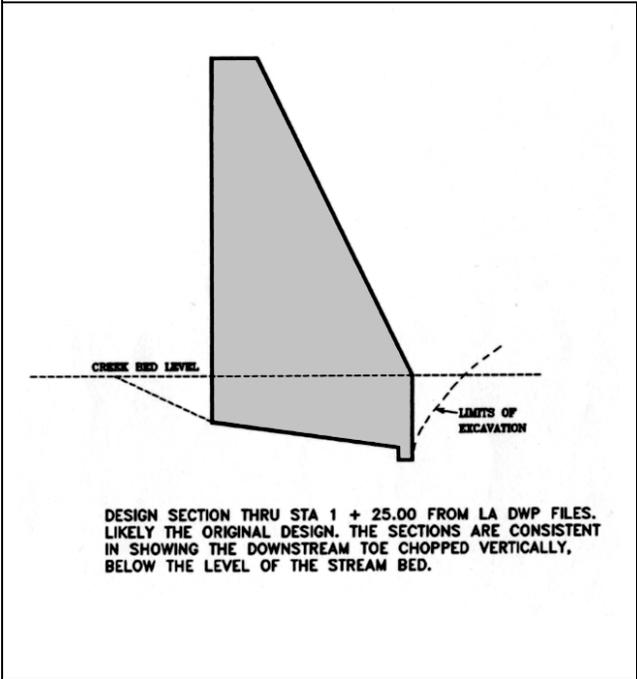
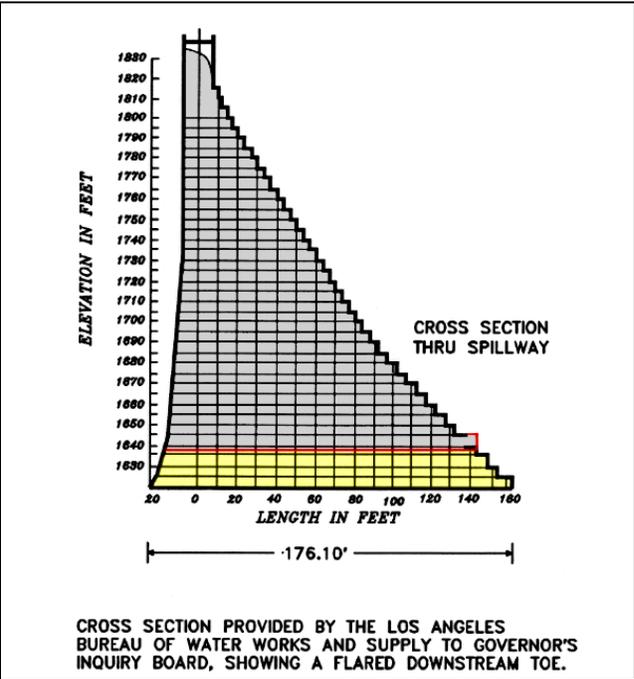
Figure 3. Comparisons between maximum cross sections of the St. Francis Dam. The upper section is what is believed to be fairly representative of the actual as-built conditions for the maximum cross section. The section at lower left is taken from the city's design files, showing the chopped base assumed in the 1923 design. The section at lower right was given to the Governor's Board of Inquiry by the city after the failure. Site photos suggest that that portion highlighted in yellow was never built, and that the maximum base width did not exceed 140 ft.

After St. Francis failed, BWWS presented the State Board of Inquiry with a standard cross section, reproduced in Fig. 3 - lower right. This section shows a battered upstream face commencing at elevation 1730, and increasing markedly, below elevation 1645, which would be considered good practice. From the photographs of Block 1 that survive, however, it is difficult

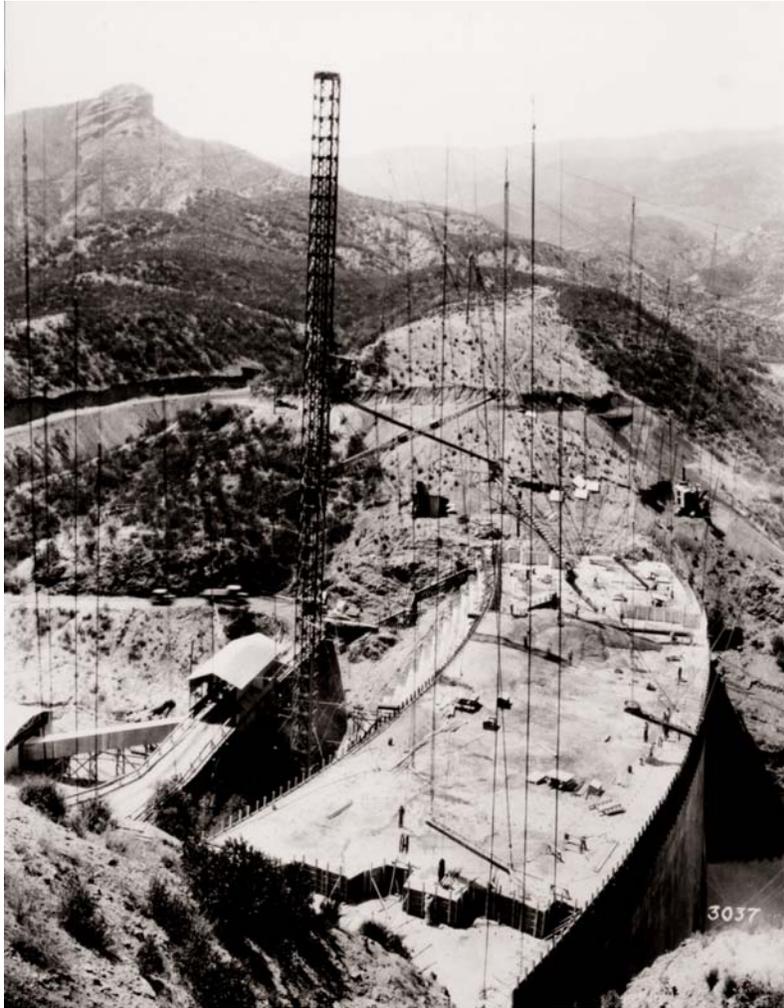
Figure 5. View looking northwest towards the left abutment, during the dam's construction, around March 1925. Shear key baffles are being placed within the dam, about 50 and 100 feet from either abutment. Note the steam shovel working on the right abutment and the contractor's tower, used to deliver concrete to the central dam area via a system of cables.

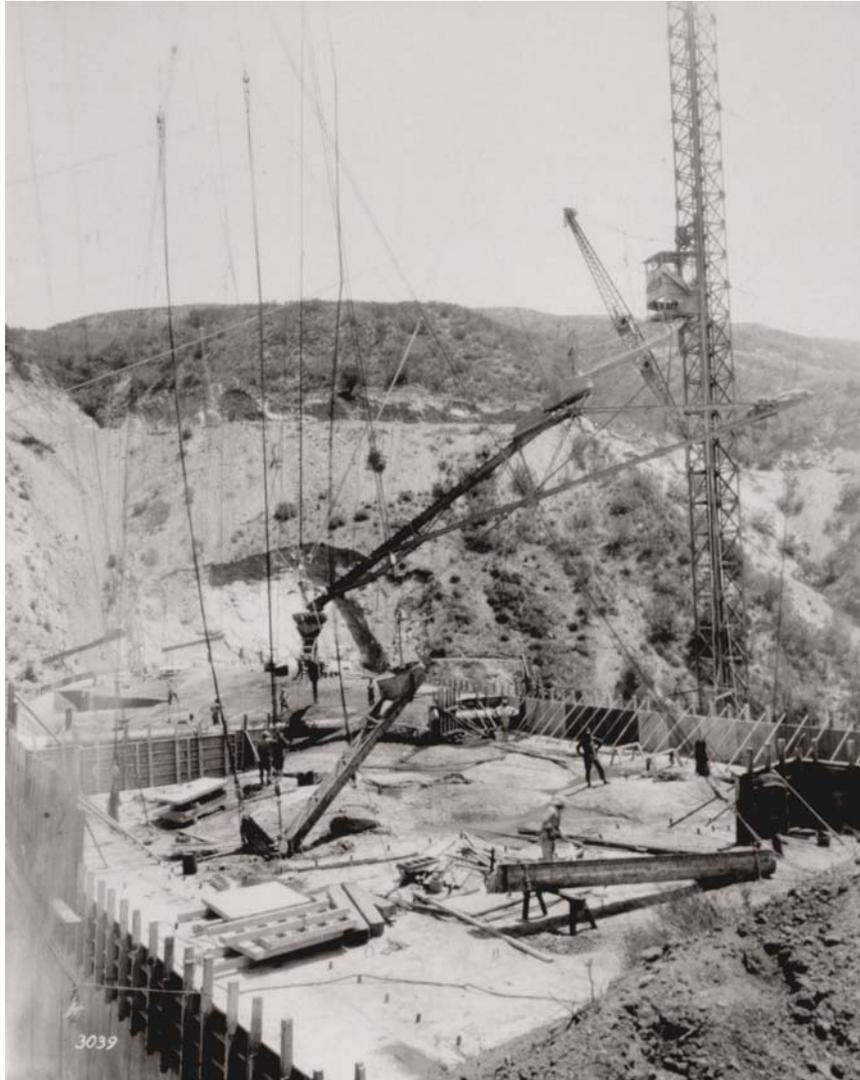
Figure 7. View looking west southwest towards the left abutment, in the Pelona Schist. Excavation of about 20 feet of schist can be seen, as well as the planar nature of the foliation surface, paralleling the abutment. Note the standing ponds of laitance moisture sitting upon the concrete pillows in foreground. Photo from L.A. Dept. of Water and Power.

Excavation into the schist on the left abutment was of similar scale, but appears to have extended about 15 to 20 feet, as suggested in Fig. 7. A cutoff trench (or shear key) about 3 by 3 feet was noted underneath some of the dam’s blocks displaced downstream after the failure (Fig. 32). With exception of the 10 uplift relief wells under the dam’s main section, the structure was bereft of any further seepage cutoff or control, such as deep cutoff walls, internal inspection galleries, seepage grout curtain beneath the dam, or uplift relief provided beneath the dam’s steeply sloping abutments. Many of these details of foundation preparation would gain industry-wide acceptance a decade later, after St. Francis failed.

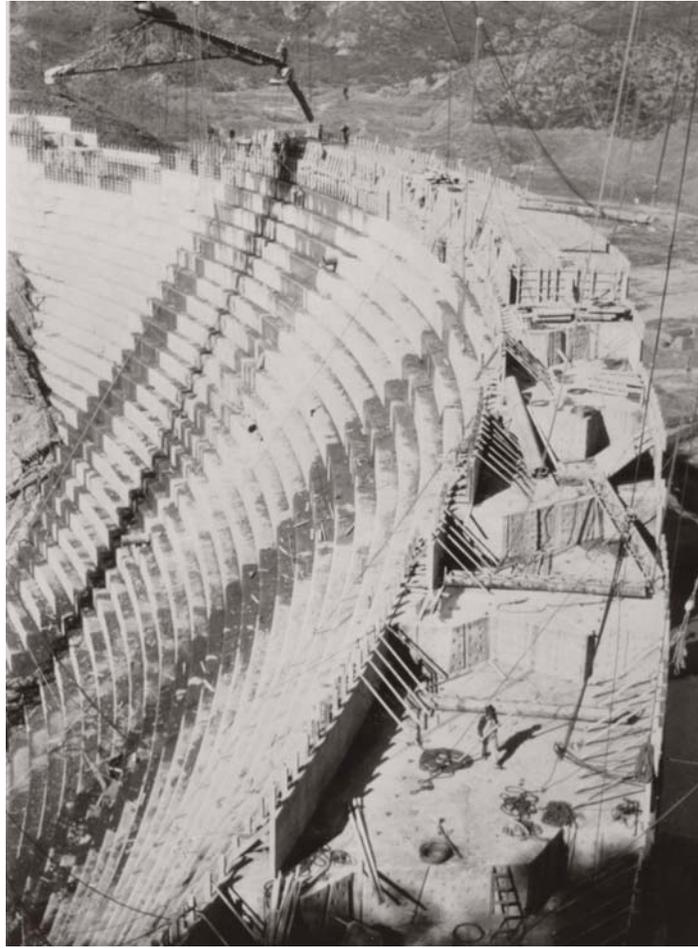
Figure 8. View of the main dam crest under construction, as seen from the left abutment crest. In this zone the shear key baffles were placed more frequently. Note how each step on the downstream face has a unique width, decreasing with upward elevation. Photo Lippincott Collection of U.C. Water Resources Center Archives.

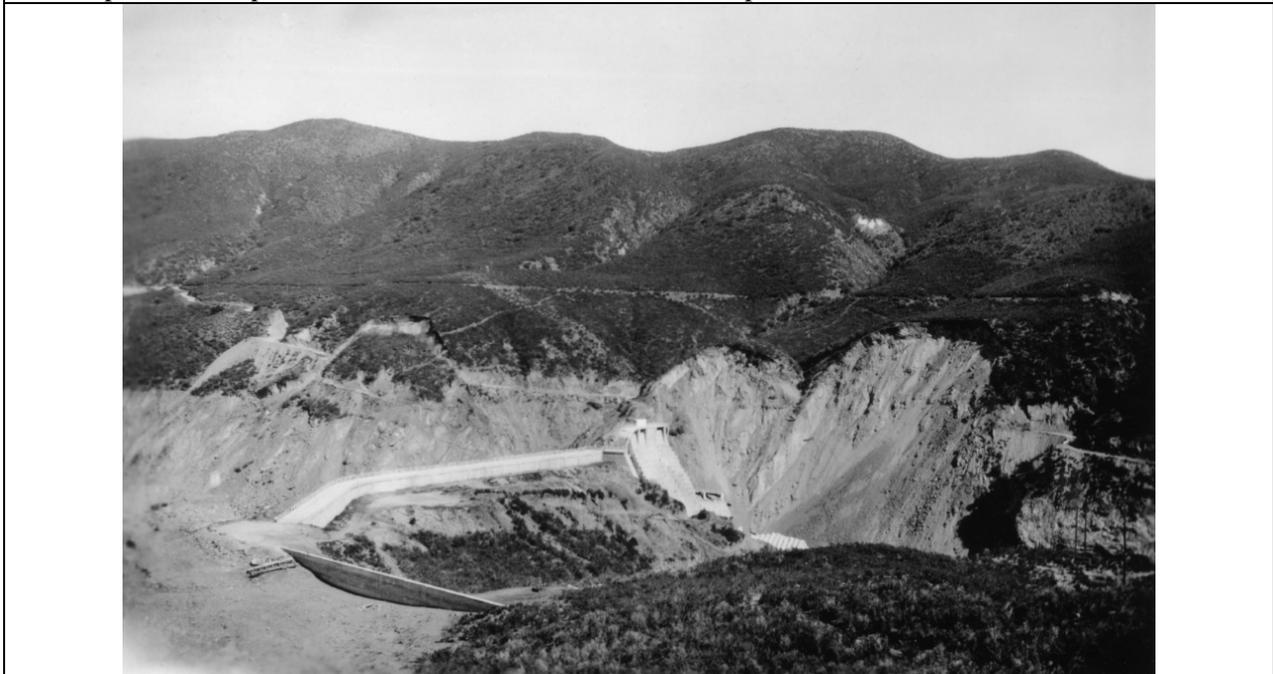
Figure 10 (lower). Same view taken after the failure. Note the prominent topographic bench in the Sierra Pelona escarpment, caused by massive landslipping. The east abutment slide is at right center. Another slump is obvious at left center, which dropped the old San Francisquito Cyn. Rd. about 50 feet (profiled in Fig. 45). From La Rue Collection at the Huntington Library.

Of great import are several facts, only briefly related here. There were several employees of Powerhouse 1 (upstream of the dam) who passed by the dam's left abutment (actually, slightly above the abutment, as seen in Fig. 10) within a few hours of the failure. One of these was the Ray Silvey family, who crossed by the dam between 8:30 and 9 PM on March 12th. Silvey was the Powerhouse 1 operator who went on shift at 11 PM, along with a Mr. Tate. Silvey later recalled crossing a crack about 12 inches high extending across the road, just upstream of the dam (see Outland, 1977, p. 234). Insofar as the road was completely upon cut in the Pelona schist (Fig. 11), this observation can only suggest incipient motion of a large bedrock landslide in close proximity of the dam's left abutment.

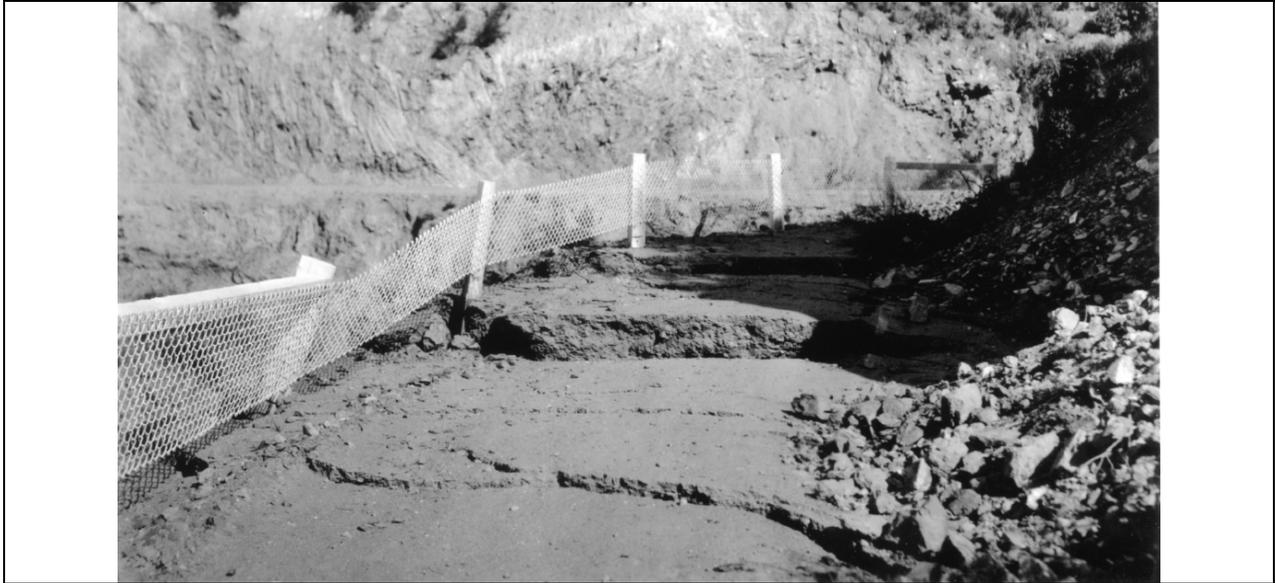
Fig. 11 - En-echelon tension cracks in San Francisquito Canyon Road several hundred feet upstream and about 20 feet above the dam's left abutment. The Ray Silvey family noted that one of these scarps was 12 inches high when they passed the dam between 8:30 and 9 PM, forcing them to stop their car and excavate ramps for their tires. These scarps were developed in the Pelona Schist. Photo by Bailey Willis, from the St. Francis Dam Disaster Collection at the Huntington Library.

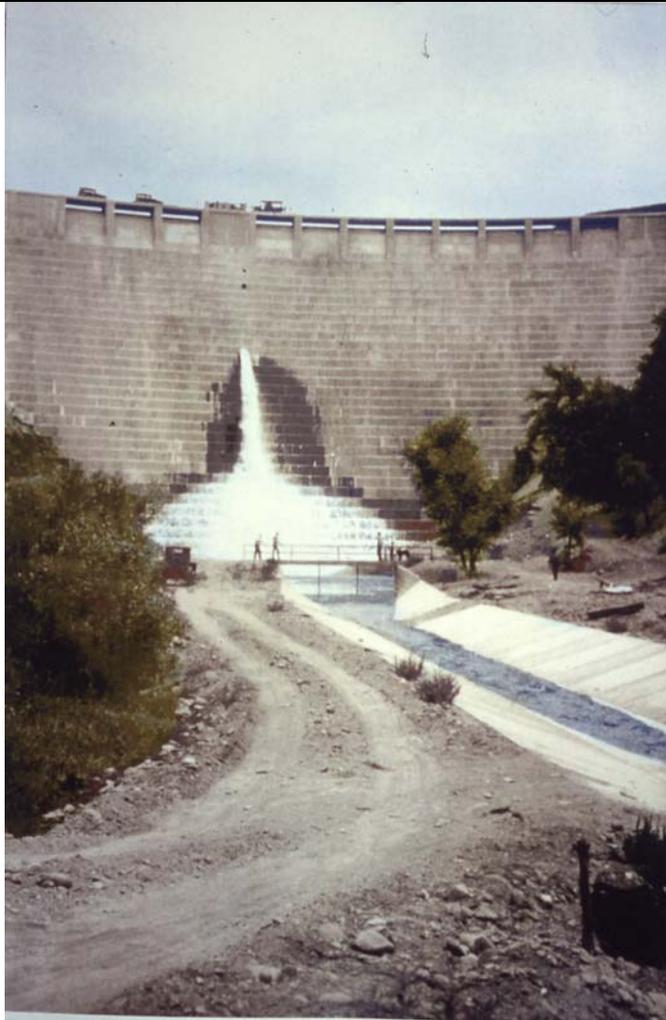
Figure 12. Frontal elevation view of St. Francis Dam, believed to be taken the day of dedication, in May 1926. Note the eleven crest spillway bays, each only 18 inches high, and the concrete-lined trapezoidal channel in foreground, which ran 7,300 feet downstream, to Powerhouse 2. Image colorized by Pony Horton.

The completed dam was opened with little fanfare in May 1926, shown in Fig. 12. The main structure incorporated eleven 20-foot wide spillway slits, only 18 inches high, and five 30-inch diameter piped outlets, seen to good effect in Fig. 12. Head gate controls for the outlet pipes and a Steven's Reservoir Stage Gage were accessed from a central control station, which can be discerned as the solid section in the fourth bay from the right abutment. These devices were situated on that portion of the dam which withstood the ensuing failure in March 1928. A concrete-lined trapezoidal channel (seen in Fig. 12) with a maximum flow capacity of 1580 cubic feet per second (cfs) was constructed between the dam and Powerhouse 2, 1.4 miles downstream, to convey outlet water from the dam to a flow gate) where discharge could be directed back into the aqueduct, or allowed to flow down San Francisquito Creek.

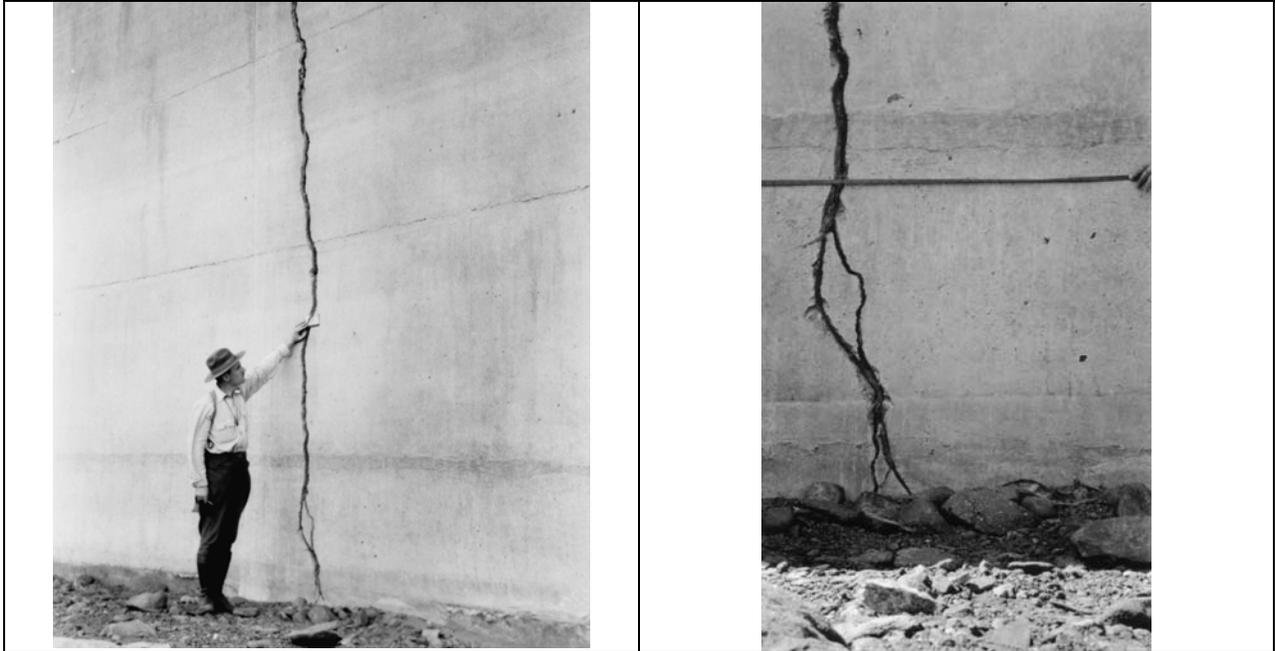
Figure 13. This was the crack discharging about 2 cubic feet per second of clear water the morning of March 12, 1928, as seen from the reservoir side, after the failure. Mulholland had come out to inspect the leak, on the opposing side of this photo, around 11 AM. Post-failure surveys indicated that the dike lifted 0.13 feet at the location, as compared to its as-built elevation. Left image from Huber Collection of U. C. Water Resources Center Archives. Right image from LaRue Collection at Huntington Library.

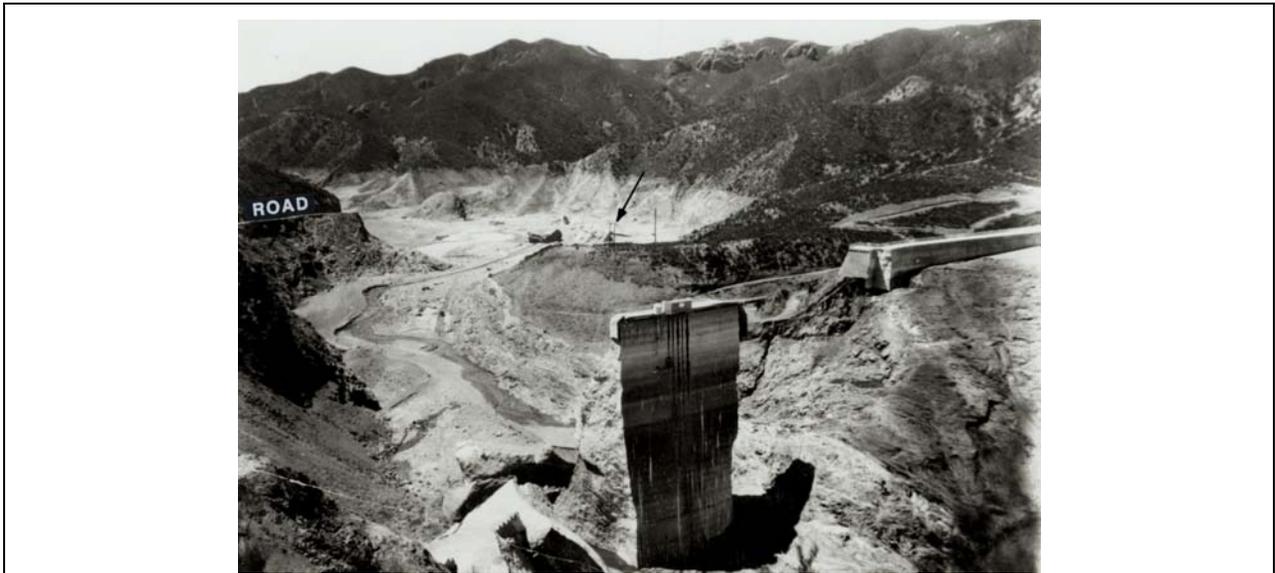
Figure 14. Downstream view of the dam site after the failure, showing location of the SCE 70 Kv Borel Power Line poles, about 60 feet above the high water mark on the right abutment, about 650 feet downstream of the dam. Photo from Ventura County Museum of History and Art.

The Southern California Edison Company's 70-Kv Borel Power Line traversed the mountain range through San Francisquito Canyon, extending eastward to Palmdale. The line was situated upon tandem sets of timber poles, and crossed the canyon about 600 feet downstream of the dam, at an elevation about 200 feet above the channel, in order to ascend the dam's left abutment (Fig.14). The line continued to rise to a position about 90 feet above the crest of the left abutment (Fig. 15). At 11:57-1/2 PM the operators at Powerhouse 1 (Silvey and Tate) noted a heavy bump, bus voltage spiking to 90, which corresponded to Southern California Edison Company's loss of power on the Borel Line. The Borel Power Lines were severed by massive landslippage of the dam's east abutment, shown in Fig.15. This suggests that the dam's catastrophic demise was ushered by a massive landslide enveloping the dam's entire left abutment, at the beginning of the failure sequence.

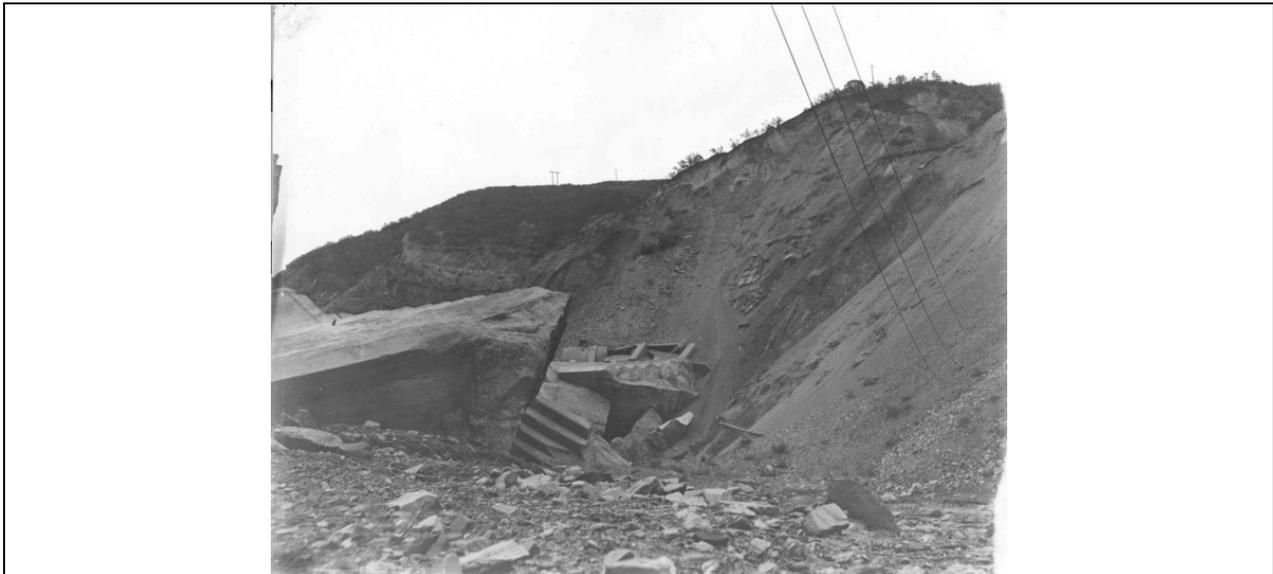
Figure 15. View looking upstream at the base of the left abutment landslide. Note the planar surface of Block 2, which broke along a cold pour joint. The three downed power lines clearly seen entering the slide area in this view had been clipped before the Governor's Board made their site inspection on March 22nd. Note tandem SCE poles in distance, upstream of the east abutment landslide. Photo by H. Wildey, author's collection.

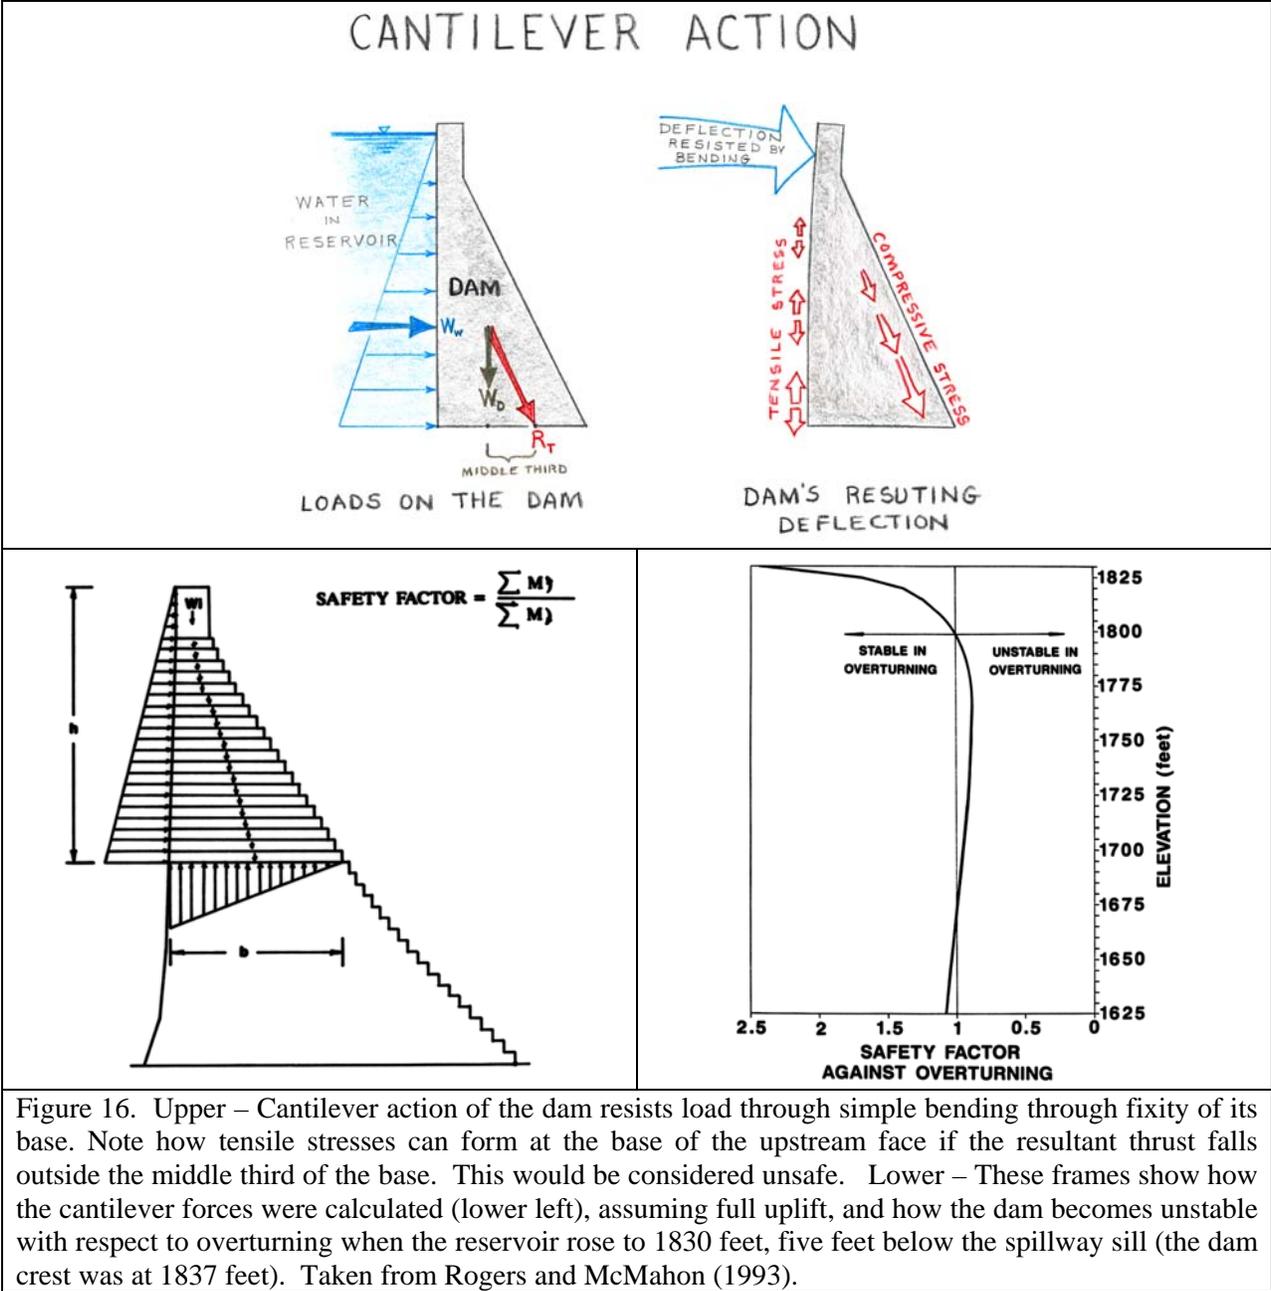
Figure 16. Upper – Cantilever action of the dam resists load through simple bending through fixity of its base. Note how tensile stresses can form at the base of the upstream face if the resultant thrust falls outside the middle third of the base. This would be considered unsafe. Lower – These frames show how the cantilever forces were calculated (lower left), assuming full uplift, and how the dam becomes unstable with respect to overturning when the reservoir rose to 1830 feet, five feet below the spillway sill (the dam crest was at 1837 feet). Taken from Rogers and McMahon (1993).

As shown in Fig. 16-upper, a mass concrete gravity dam cannot theoretically sustain tension in its heel, or it becomes unstable in overturning. The resultant thrust (R_T) is the vector sum of the dam's dead weight (pushing downward) and the pressure of the reservoir water (pushing horizontally, against the dam). The inclination of the resultant thrust must remain within the middle third of the dam's base to prevent the heel from separating from the underlying foundation. For this reason, masonry dams over 200 feet high are generally battered on their upstream face, to widen their footprints and, thereby, keep their upstream heels out-of-tension.

-lower right shows the results of these summations. These back-analyses revealed that the structure becomes unstable in overturning when the reservoir pool was raised to within five feet of the spillway lip (elevation 1830 feet), a condition that occurred five days previous to the failure (Rogers and McMahon, 1993). The reservoir pool had been brought up to within 3 feet of spillway sill the previous year for just one day (May 10th), then maintained at 4 feet below crest for another two weeks, until May 25th, when it was drawn down to 1812 to 1820 ft through the balance of the year. The reservoir pool was then brought through elevation 1830 on February 5th, and maintained above this level for the next 36-1/2 days, until the failure. This would have allowed time for increased percolation beneath and around the dam, into its abutments.

After the dam failed, half the central core remained standing, shown in Fig. 16 left. The pencil record of reservoir stage was recovered from the mechanical drum of the Steven's Reservoir Stage Gage sitting on top the remaining section, which was re-set by winding the device's counterweight every seven days (see sidebar description). The gage had been rewound on Sunday March 11th, the day preceding the failure. The Stevens Gage showed a peculiar drop (Fig. 19) in the reservoir, beginning about 40 minutes prior to the dam's collapse, at 11:57-1/2 PM.

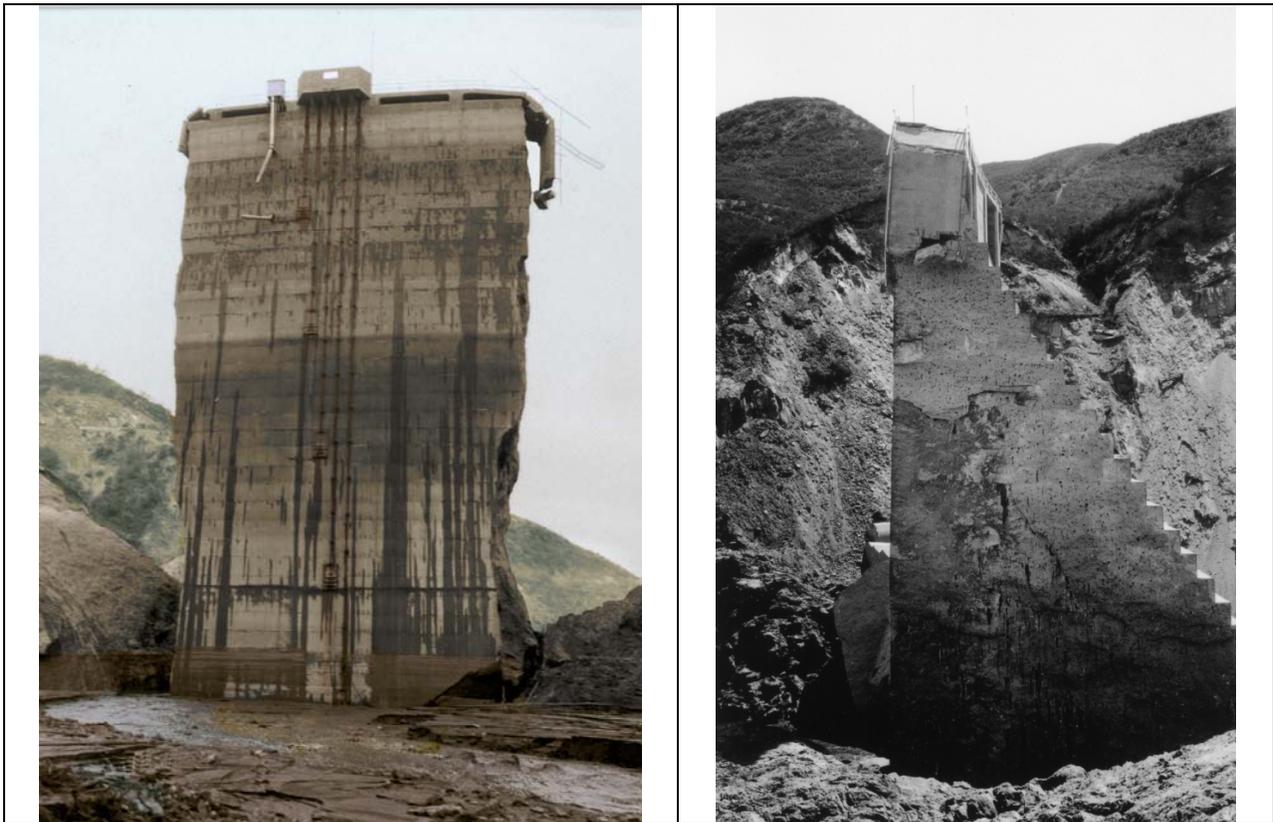
Figure 17. Left - Carl Grunsky discovered the gage attendant's wooden ladder wedged inside an enormous tension crack in the right upstream heel of Block 1 (from Ventura County Museum of History & Art; colorized by Pony Horton). Right - Profile view of the Block 1 monolith. No discernable upstream batter can be seen near elevation 1730, about half the height of the block (from La Rue Collection of the Huntington Library).

One of the most interesting aspects of the post-mortem analyses of St. Francis Dam concerns the massive tension crack exposed in the upstream heel of Block 1, discovered by San Francisco engineer C. E. Grunsky (see sidebar discussion) about two weeks after the failure, when the ground around the upstream face of Block 1 had drained sufficiently to see more details. The wooden ladder (Fig. 18) came from a position about 50 feet southeast and 100 feet below where it was affixed to the dam's upstream face, between the Stevens Stage Gage stilling pipe and the pull-rod for Outlet Sluice Gate No. 2 (see left side of Fig. 17 left, below).

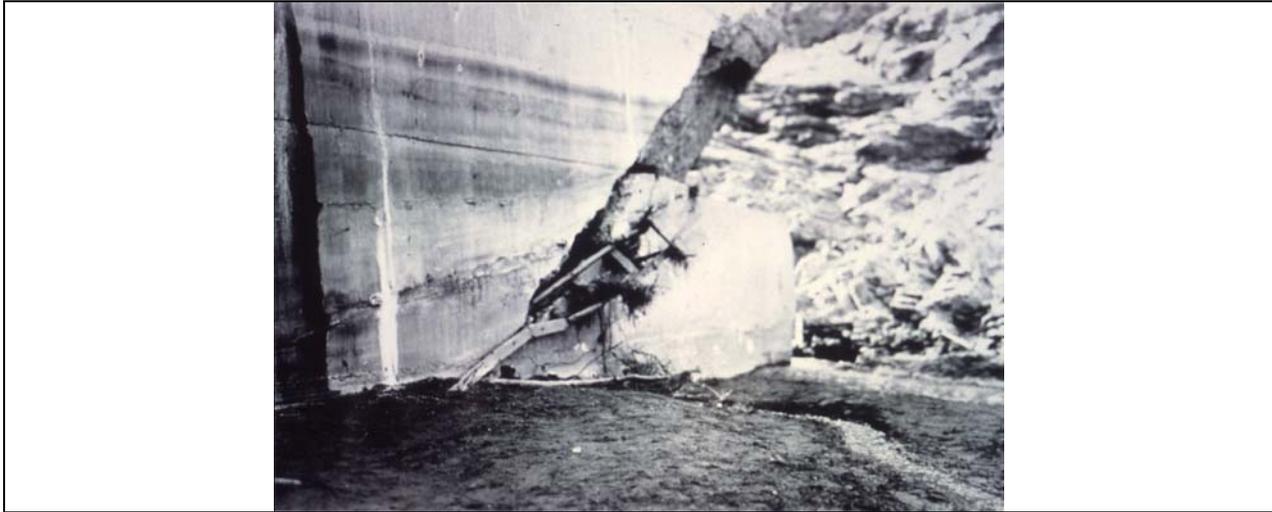
Figure 18. Detail view of the wooden gage attendant's ladder found in a large tension crack in the right upstream heel of Block 1. This testifies to significant deformation of Block 1, tilting downstream under active hydrostatic pressure. Some of this may have occurred after Block 2/3/4 fell away, removing lateral restraint on the left side of Block 1. Photo taken from Outland (1963).

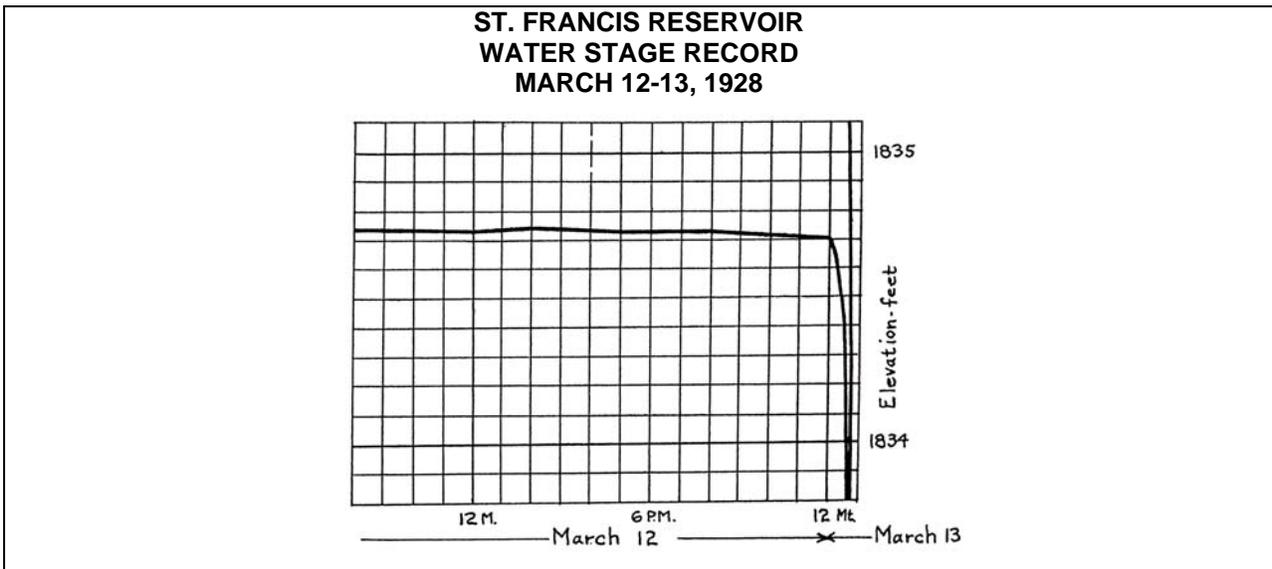
Figure 19. Charles Lee's reconstruction of the Steven's Gage record recovered from the crest of Block 1 after the failure. Note the increasing drop in reservoir stage that began about 40 minutes prior to the 11:57-1/2 PM failure. Lee (1928) recognized that this deformation might have come from the left abutment pushing against the dam and "lifting it slightly." The gage appears to have recorded cantilever deformation of the main dam, deflecting almost two degrees from vertical when the dam collapsed.

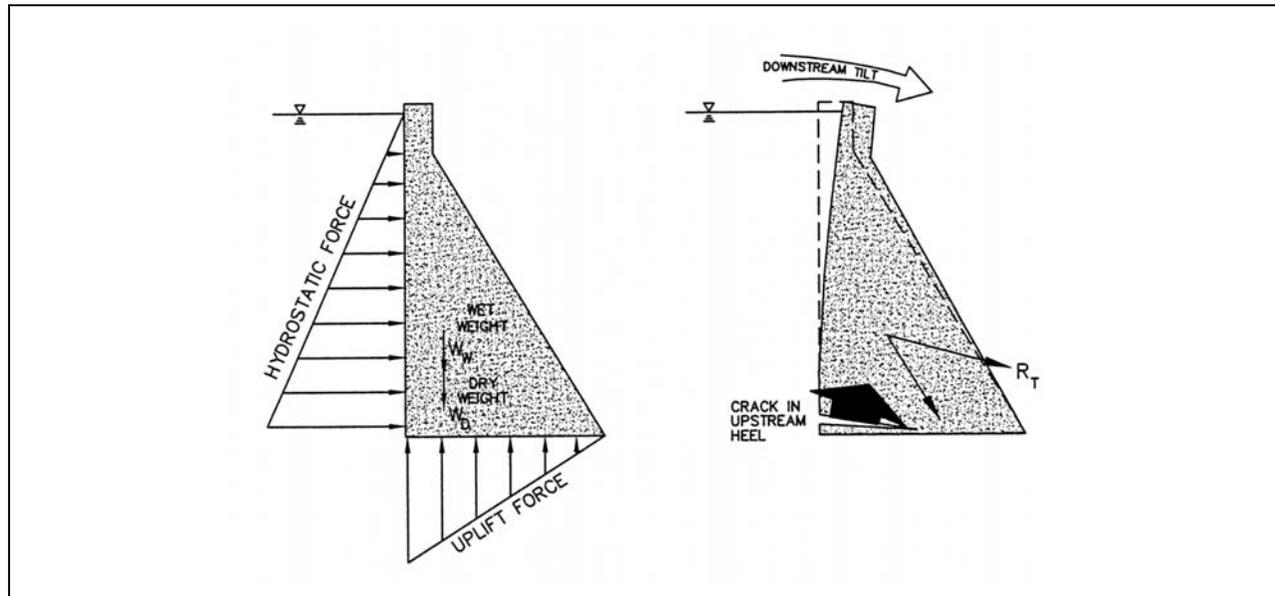
Figure 20. Left - The resultant thrust within a gravity dam is the vector sum of the horizontally-inclined hydrostatic force and the vertically-inclined dead weight of the dam. Stability in overturning requires that the resultant thrust R_T be within the middle third of the dam's base. BWWS engineers ignored uplift forces in their analyses because they installed 10 uplift relief wells under this portion of the dam, which did not fail. Right - The Steven's Gage attached to Block 1 faithfully recorded a drop of 12 inches in 40 minutes, which would equate to a 2 degree tilt about an axis of rotation at the deepest point of Block 1, about 106 feet downstream of the dam's upstream heel.

The existence of such a large tension crack in this portion of the dam was mute testimony of a seriously overstressed structure. Subsequent structural analysis by the author revealed that the presence of a crack in the heel of Block 1 would have shifted the dam's resultant thrust some 240 feet downstream of the dam, when it would need to be within the middle third of the dam's base to maintain stability (Figs. 16 and 20). No dam could withstand such imbalance, as the reservoir's full hydrostatic pressure would have entered such a fracture and greatly reduce the effective weight of the dam's concrete. These findings suggest that the progressive drop in reservoir level recorded by the Stevens Stage Gage during the hours preceding the failure appear to correspond with tilting of the dam's central core, due to its being overstressed (Fig. 20). So, it

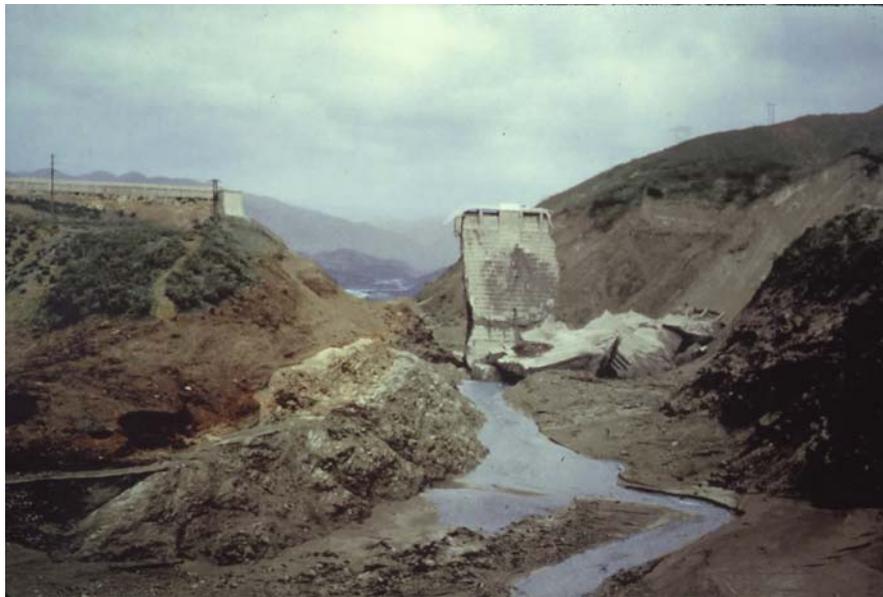
Figure 22. Upstream view of the dam site, taken within five days of the failure, when the downed power lines were still visible, leading into the left abutment landslide. Note position of the intact power poles high above the reservoir water line in background. Photo from C.H. Lee Collection, U.C. Water Resources Center Archives, colorized by Pony Horton.

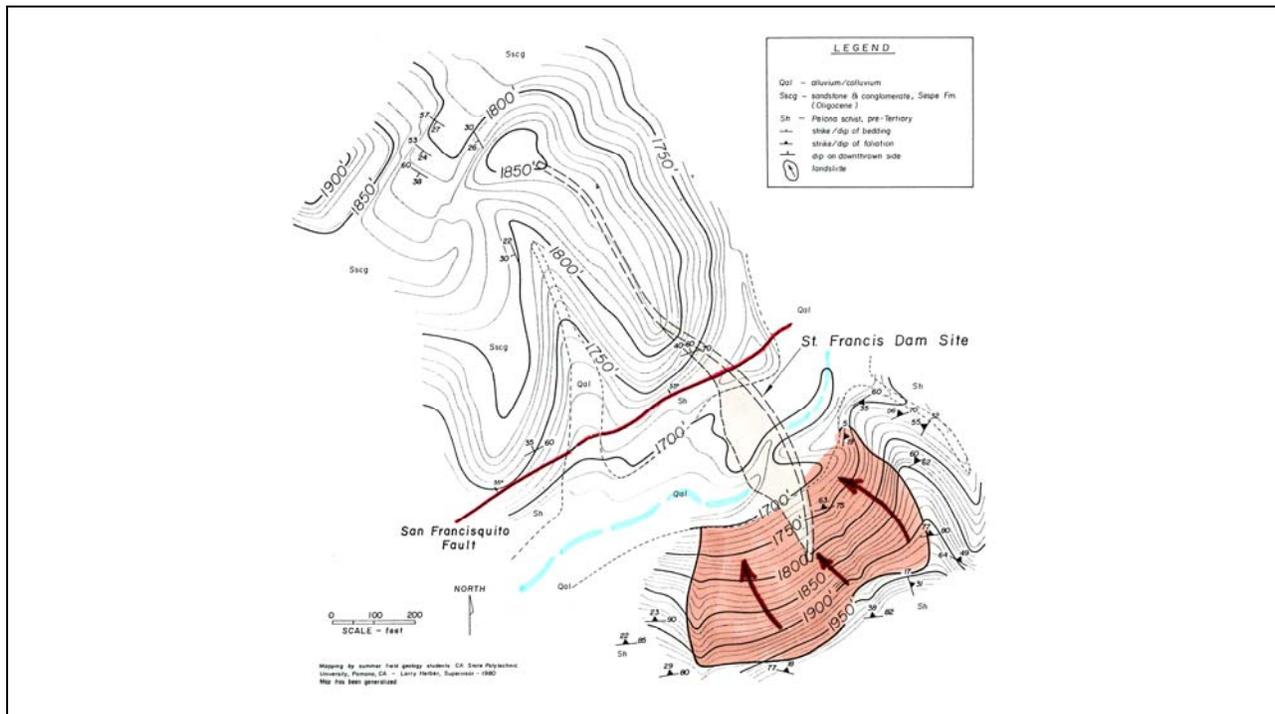
Figure 23. Plane table topographic map of the existing dam site made by students at Cal Poly Pomona in 1980. The original position of the dam is shown in its former position, using survey data provided by LADWP. Note position of the dam crest with respect to the left abutment landslide, right in its center.

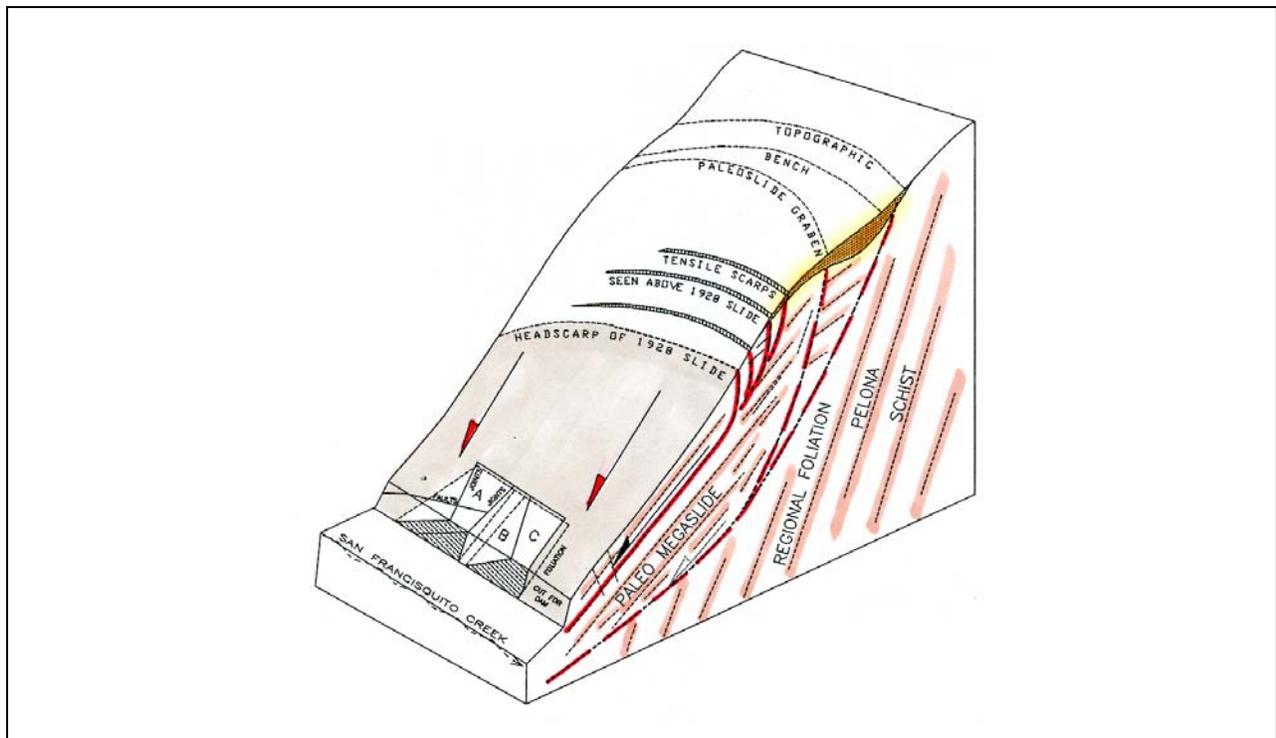
Figure 24. Schematic block diagram of the base of the dam's east abutment, showing rock wedges A, B and C in the Pelona schist predicted by the keyblock analysis. A 60° cut at the base of the left abutment created an unstable situation with respect to this family of keyblocks, based upon measurement of discontinuity suites recently measured in the left abutment scar.
