The 1928 St. Francis Dam Failure and Its Impact on American Civil Engineering

J. David Rogers

THE 1928 ST. FRANCIS DAM DISASTER

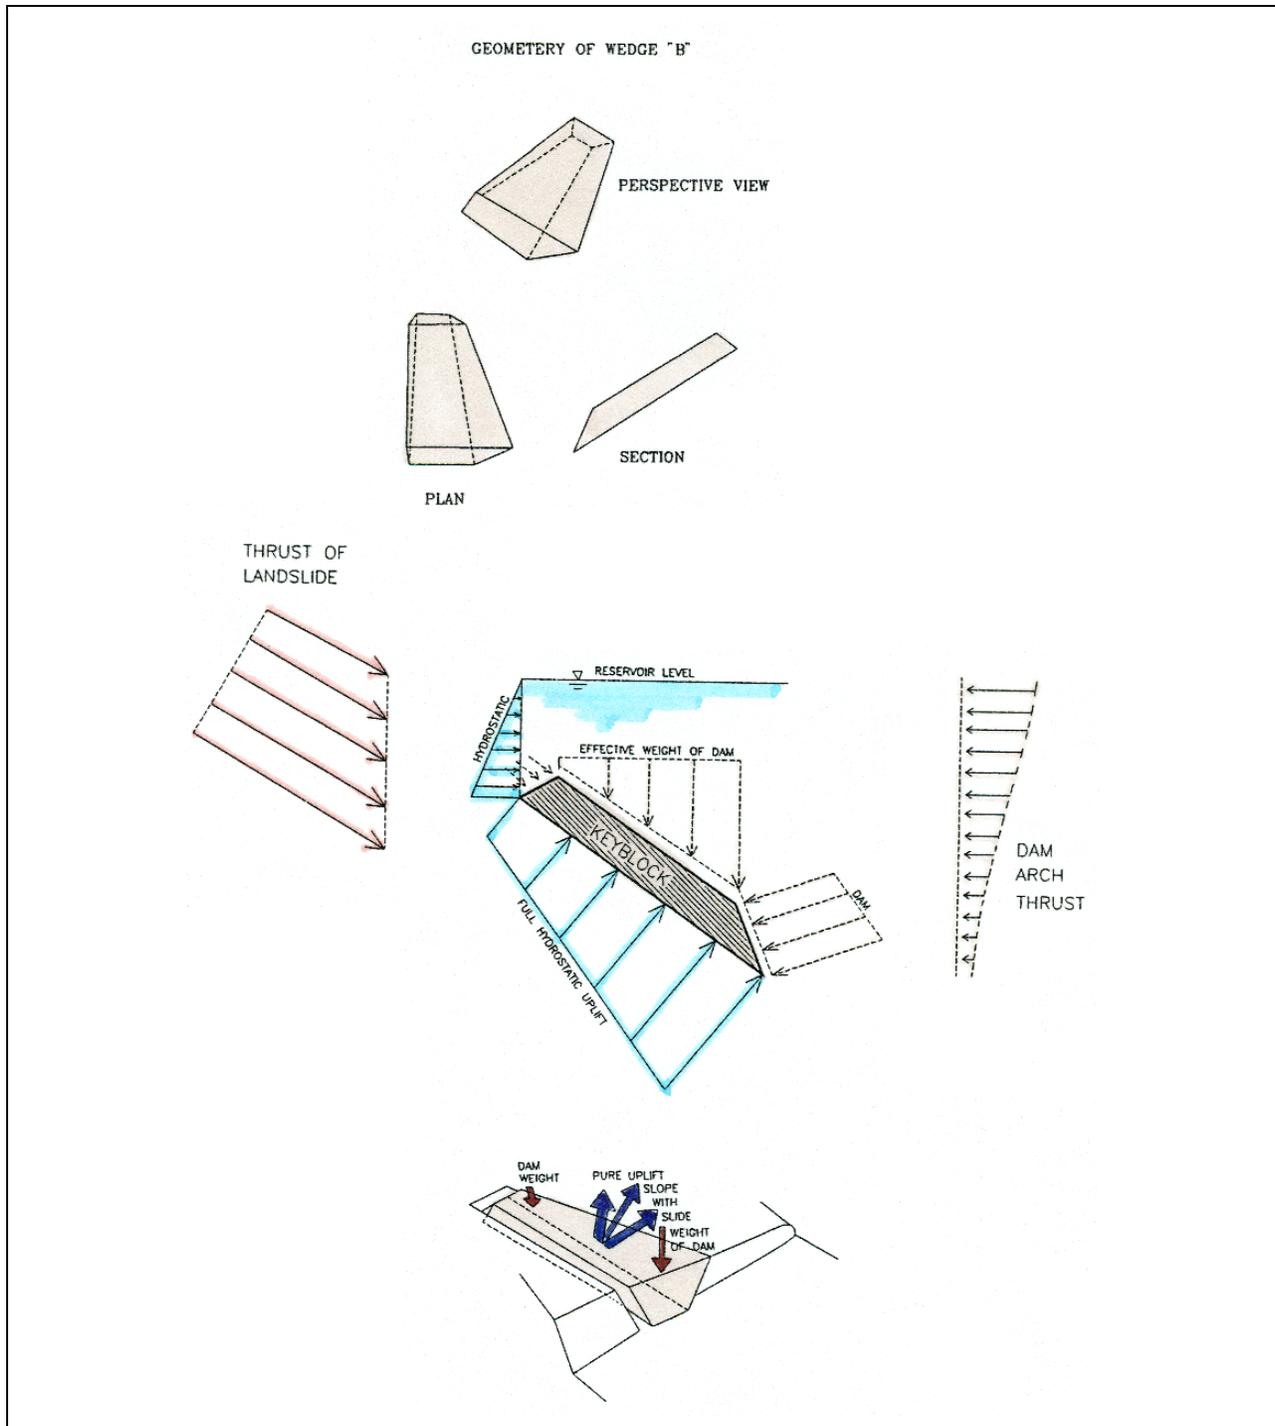
Figure 25. Plan, elevation and perspective views of keyblock B, shown in the previous figure. The elevation view (middle) parallels the foliation of the schist, normal to the dam's abutment. The forces acting upon this block are sketched in. Full hydrostatic uplift would be acting upon the block because the sloping abutments were without any manner of seepage cutoff, grout curtain, or uplift relief wells. The lower figure shows the predicted uplift of keyblock B, in vicinity of Block 35 (Fig. 40).

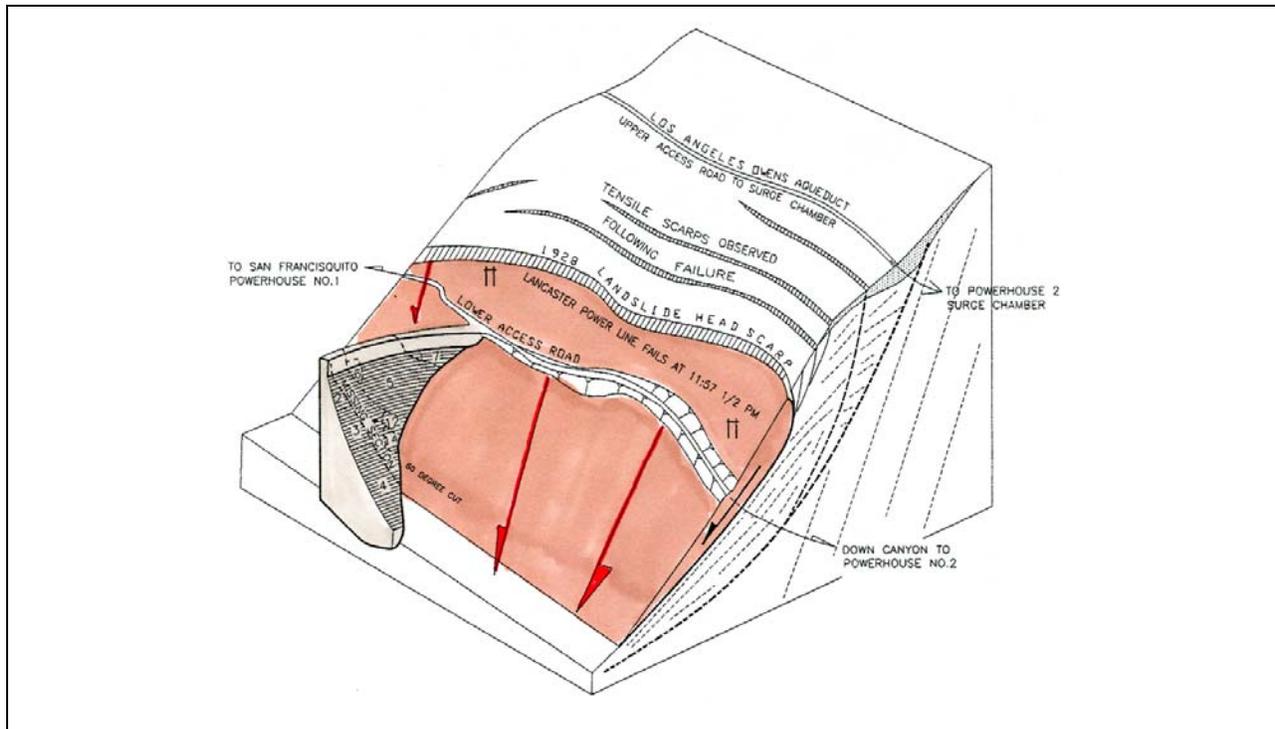
Figure 26. Schematic block diagram of the left abutment area, showing the approximate areal limits of the 1928 east abutment landslide. Bailey Willis (1928) was the only person who recognized that the east abutment slide was only a small portion of a much larger prehistoric landslide developed within the schist.

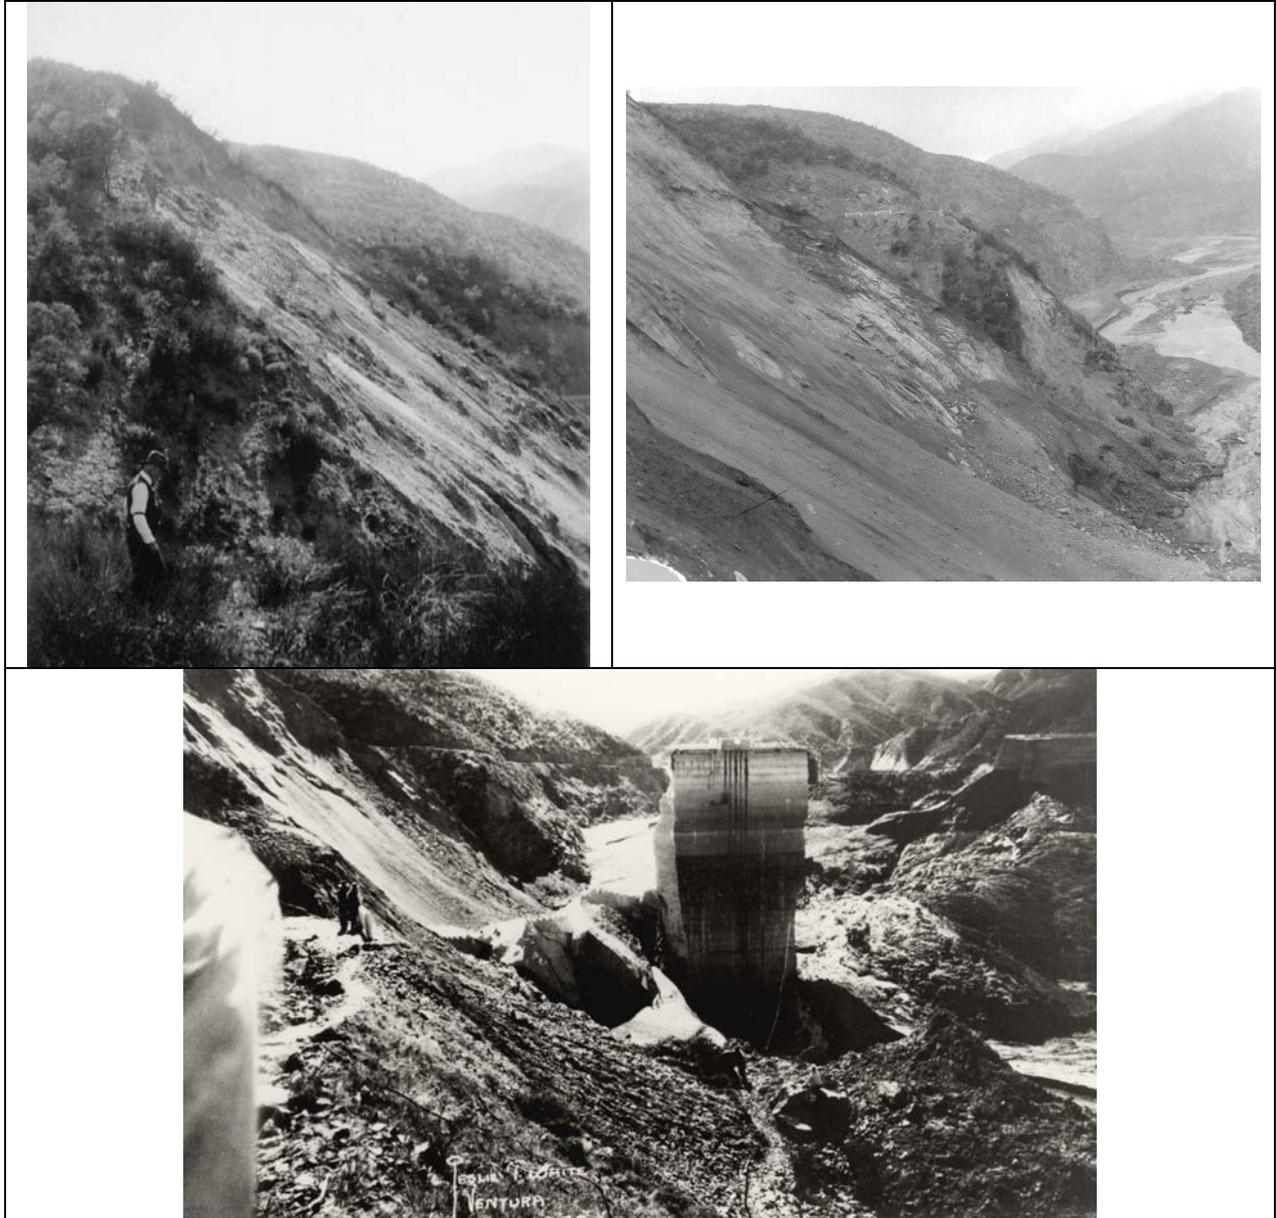
Figure 27. Upper - Downstream views of the planar foliation surface exposed in the east abutment landslide. Note the near vertical headscarp, about 40 feet high (from Grunsky report in St. Francis Dam Disaster Collection at the Huntington Library). Lower – A similar view, but taken from behind the dam. The left abutment slide carried the dam’s sloping abutment section across the downstream face of the main structure, from left to right (Ventura County Museum of History and Art).

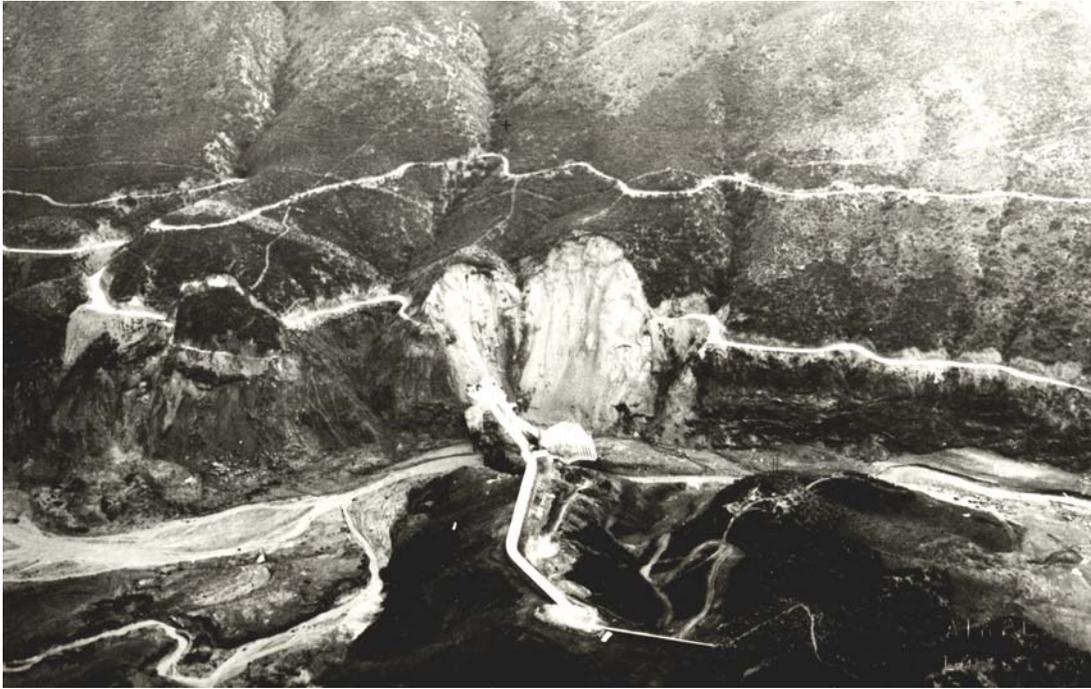
Figure 28. Aerial oblique view of the dam site by Spence Aerial Surveys the morning after the failure. Note the position of the east abutment landslide and old San Francisquito Canyon Road with respect to the dam (from the UCLA Spence Photo Collection).

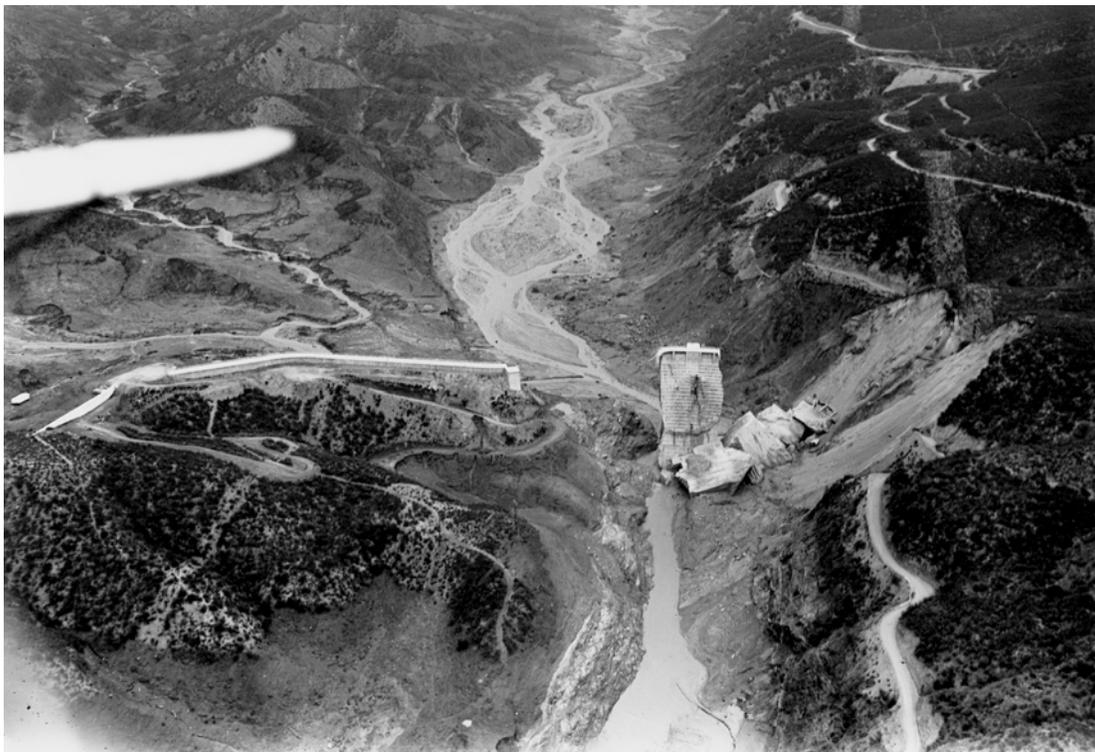
Figure 29. Aerial oblique view looking upstream at the dam area the morning after the failure. Note how high the east abutment landslide extended above the reservoir. Also, note the massive slump block upstream of the dam, caused by rapid drawdown (UCLA Spence Photo Collection).

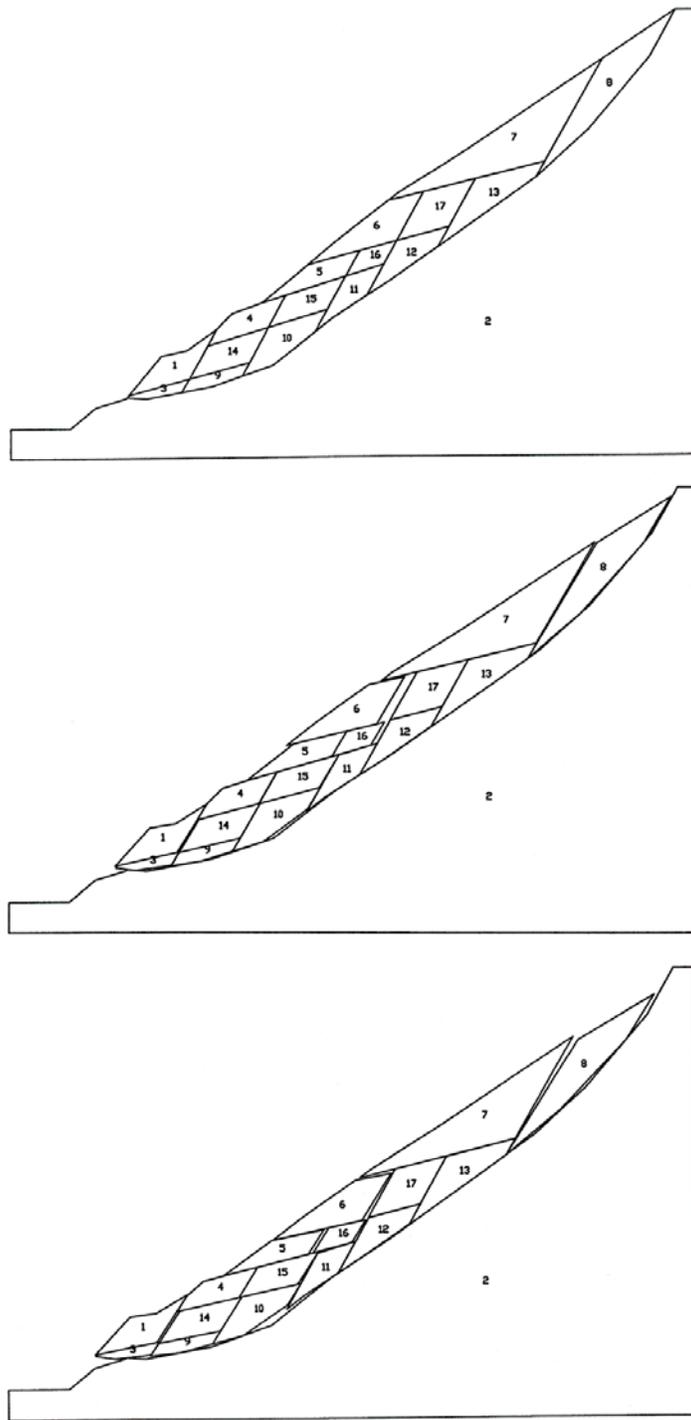
Figure 30. Discontinuous Deformation Analysis of the east abutment landslide, performed by Max Ma. These sections show the destabilizing effects of lateral loss of restraint that triggered upslope migration of the slide mass. Pore pressure entrapment likely developed at the base of the slide, beneath wedges 3, 9, 10 and 11, reducing the friction along the planes of schistosity.

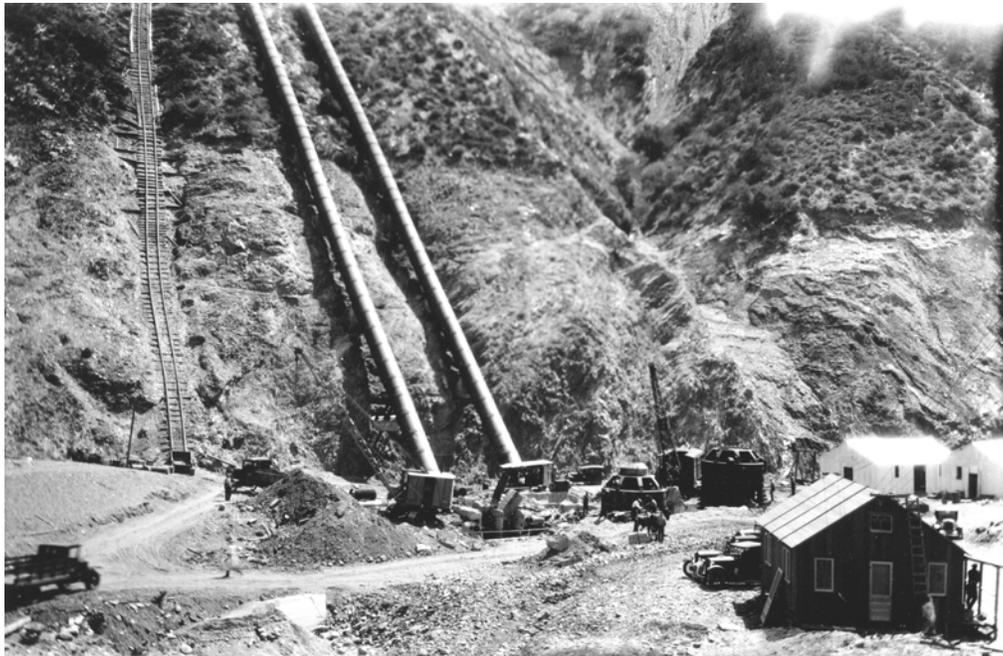
Figure 33. Rebuilding activities at Powerhouse 2 a few weeks after the failure. Surge chamber attendant E. H. Thomas descended the slope along the tramway tracks at left, reaching the high water mark at 12:15 AM, and noting that the flood waters had already dropped 20 feet. The maximum depth of flow here was about 110 feet above the channel (Huber Collection, U.C. Water Resources Center Archives).

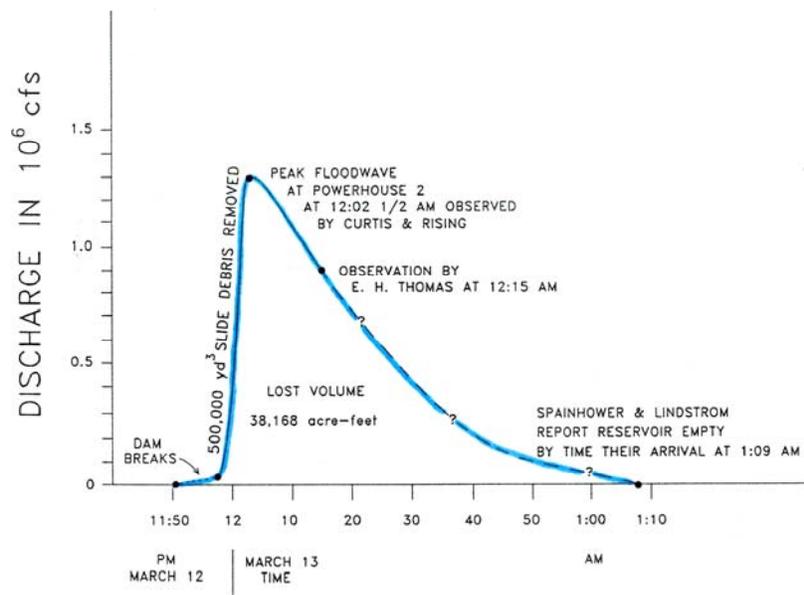
Figure 34. Reconstructed hydrograph for the outbreak flood at Powerhouse 2, approximately 7,300 feet downstream of the dam. Observations and times of events at this location, allowed for the reconstruction using modern methods of channel hydraulics.

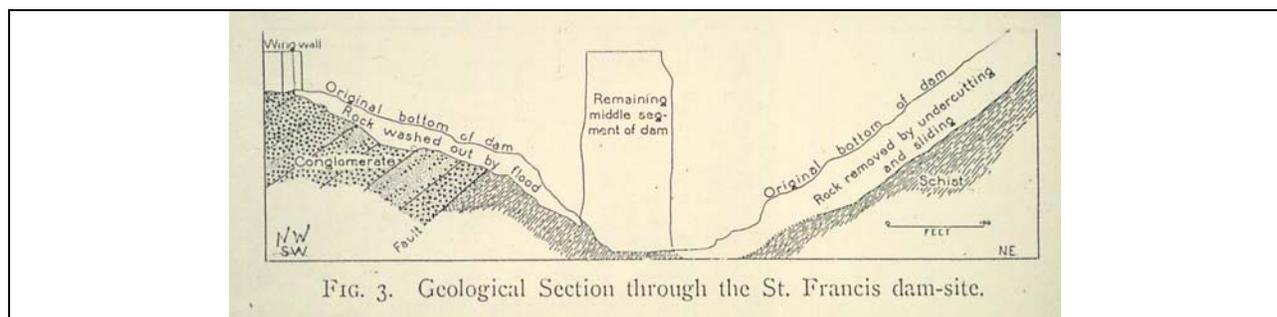
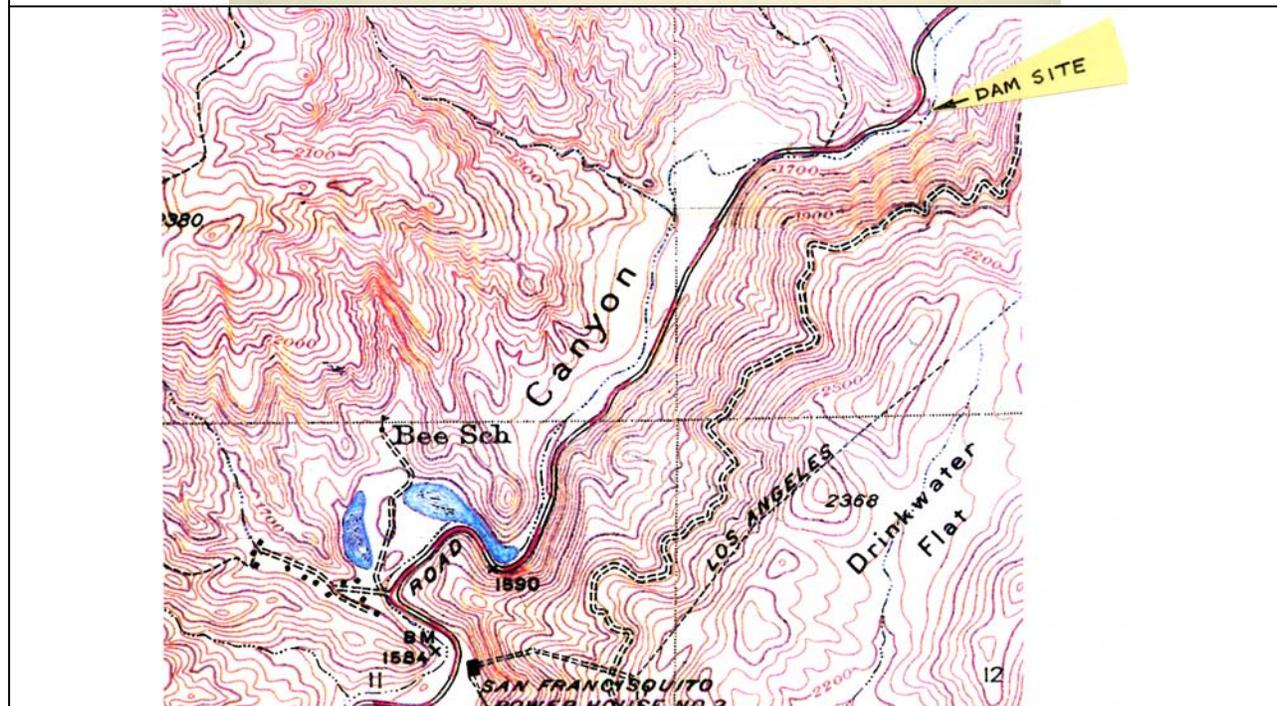
Figure 35. Upper – An outbreak flood hydrograph could not be estimated for the dam site initially, because the cross sectional area of flow would have been changing each second that side slope debris and portions of the dam were removed by the outpouring reservoir water (from Ransome, 1928). Lower - Portion of the Red Mountain 6-minute quadrangle released in 1936 which includes the St. Francis Dam site and DWP Powerhouse 2. This map was used in the forensic reconstructions of the outbreak flood hydrograph. The two lakes upstream of the powerhouse were filled by the city in 1952.

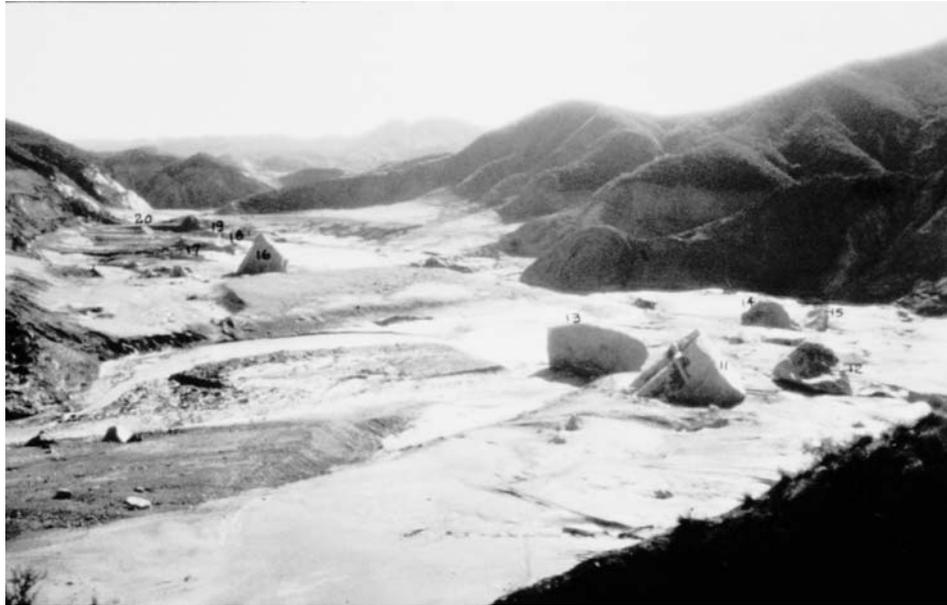
Figure 36. Displaced blocks of the dam, as viewed from a position about 1,000 feet downstream of the dam site. The block numbers written on the photo are those of the State Board of Inquiry (Fig. 38). Although Blocks 12 and 14 came from the base of the left abutment, they were situated between 22 and 26 feet higher than Block 16, seen further downstream and within the low flow channel.

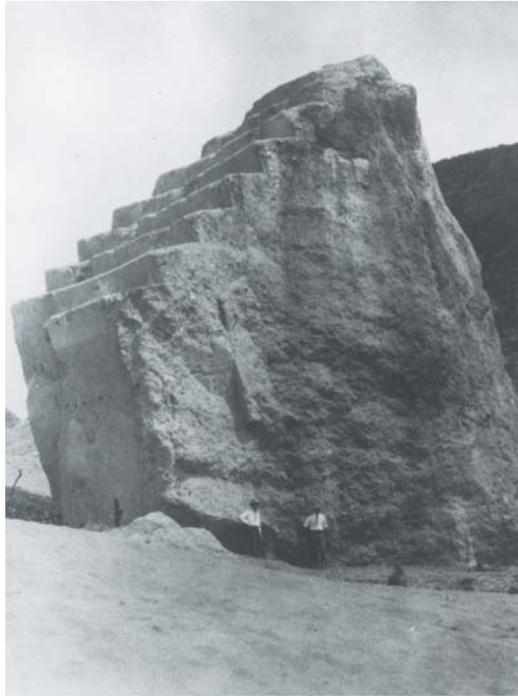
Figure 37. Close-up view of Block 16 (State designation) or 44 (BWWS designation), at 10,000 tons, the largest of the dam's displaced blocks. It was found about 1,500 feet downstream of the dam. The only plausible mechanism by which such a large block could be hydraulically transported would be by saltation in a dense slurry, akin to a massive debris flow. Photo from the Lee Collection, U.C. Water Resources Center Archives.

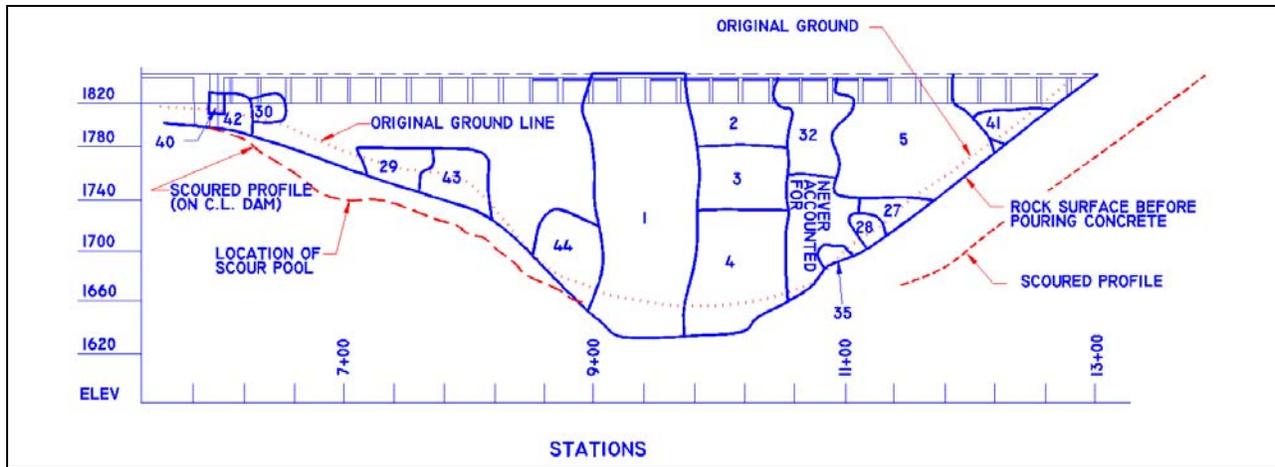
Figure 39. Upstream elevation view of the St. Francis Dam showing blocks positively identified by Charles Lee and Ralph Proctor, during surveys performed in March, April and May 1928. Note that many of the block designations differ from those presented in the State report, shown in the previous figure.

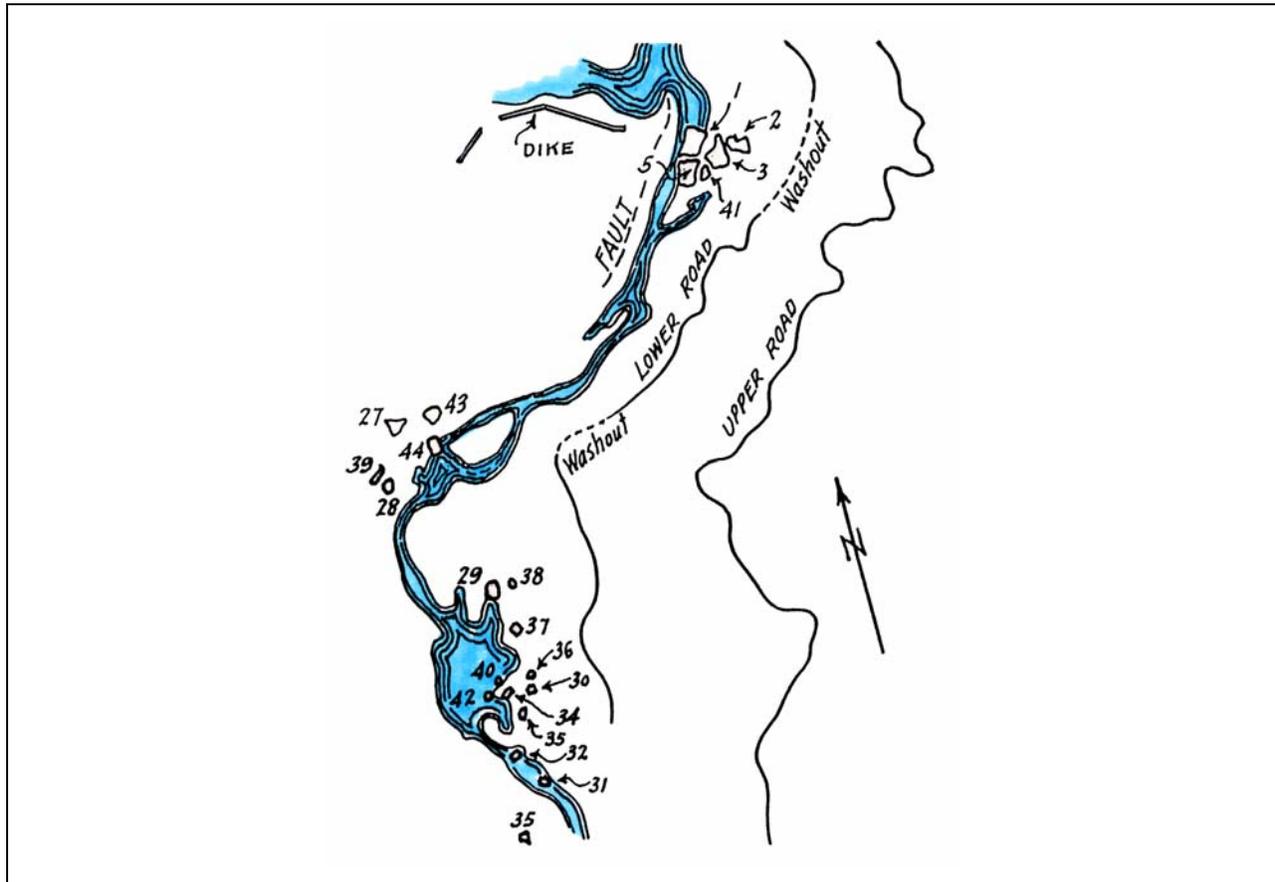
Figure 40. Plan view of the dam's displaced blocks determined by Lee and Proctor. This figure is an overlay of an annotated aerial photograph, and is not spatially corrected for parallax distortion on the photo. Of interest are the positions of Blocks 32 and 35, from the missing section on the left abutment, found furthest downstream.

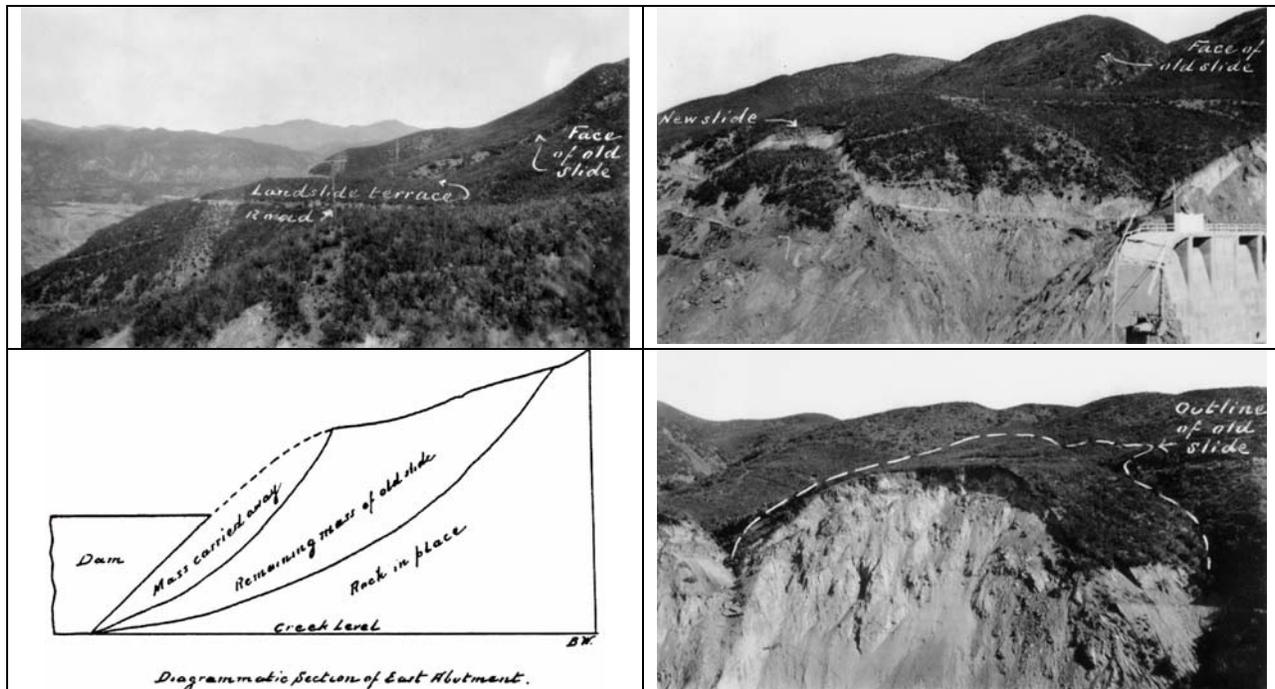
Figure 43. Some of the key figures from Willis June 1925 article in Western Construction News. The upper left image shows the old landslide terrace developed in the Pelona Schist above the reservoir area. The image at upper right shows one of the landslides that slipped into the reservoir due to rapid drawdown. The lower images show a hypothesized cross section through the east abutment landslide (left), suggesting that most of the pre-existing bedrock slide forming the dam's left abutment was not mobilized in the failure (photos courtesy of the Grunsky family).

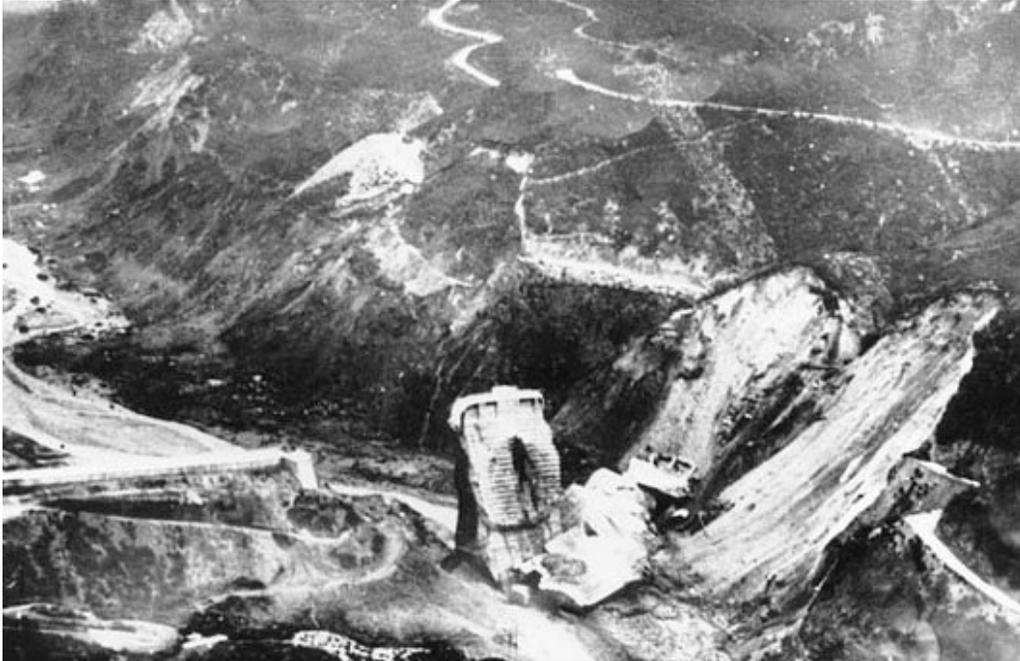
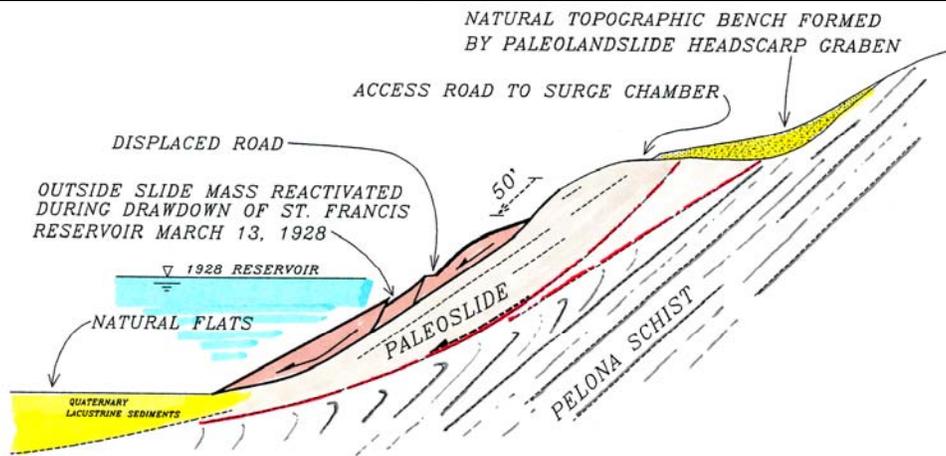
Figure 44. Upper image shows the large slump block that dropped into the reservoir upstream of the dam, due to rapid drawdown of the reservoir (from UCLA Spence Collection). Lower figure from Rogers (1992) shows a cross section through this slump block based on field reconnaissance. It appears to be a retrogressive translational block glide that moved about 50 feet. Note how only a small fraction of the parent slide mass was involved.

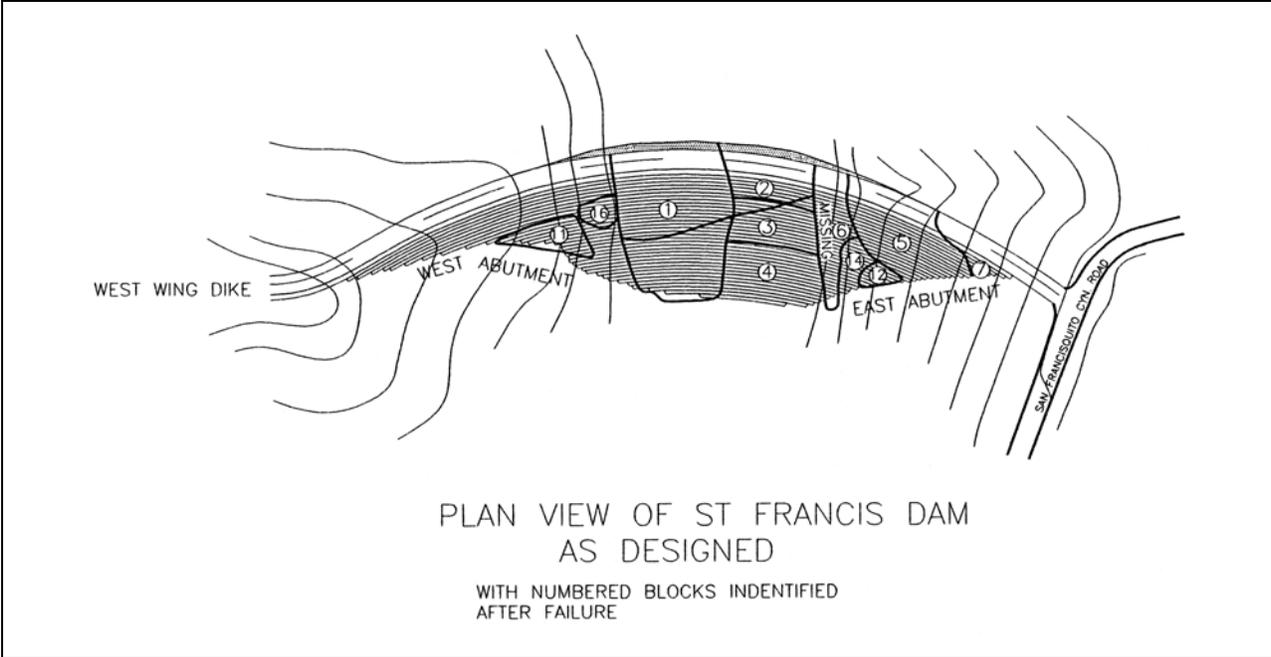
Figure 47. Plan view of the main dam, as originally designed. Diagonal lines and numbers delineate dam blocks with the State’s nomenclature (as presented in Fig. 38). The dam’s vertical steps were each 5 feet high, but the horizontal distances varied from 5.5 feet at the bottom to 1.5 feet near the top.

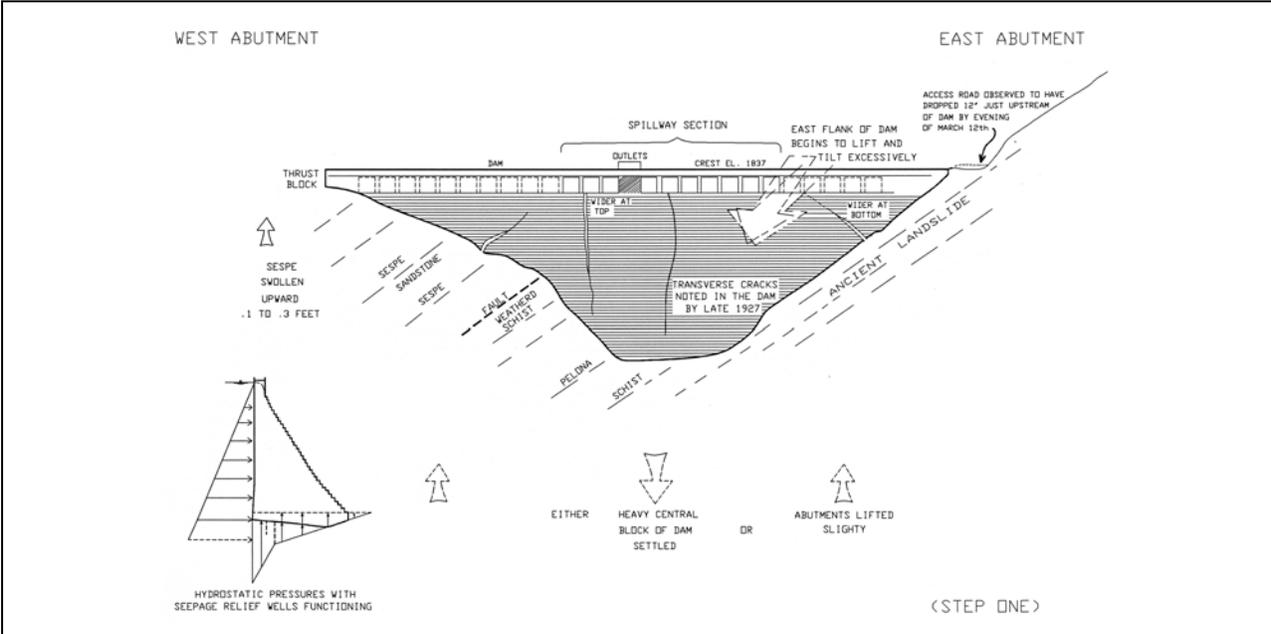
Figure 48. Schematic elevation view of the dam with transverse cracks which appeared on the downstream face of the dam a year previous to the failure. The dam was built without contraction joints. Some hydrostatic pressure relief was afforded the central core of the dam, as shown at lower left. This portion of the dam did not fail, only the sloping abutments failed.

significant thermal stresses and shrinkage of the mass concrete. 130,446 cubic yards of concrete were placed at St. Francis in just 16 months, without any attempt at cooling the concrete. As a consequence, some rather large contraction cracks formed in the monolith, which were plugged with oakum (dry wedges of oak wood, pounded into the cracks) in 1926-27 (those positions on the downstream face are portrayed in Fig. 49).

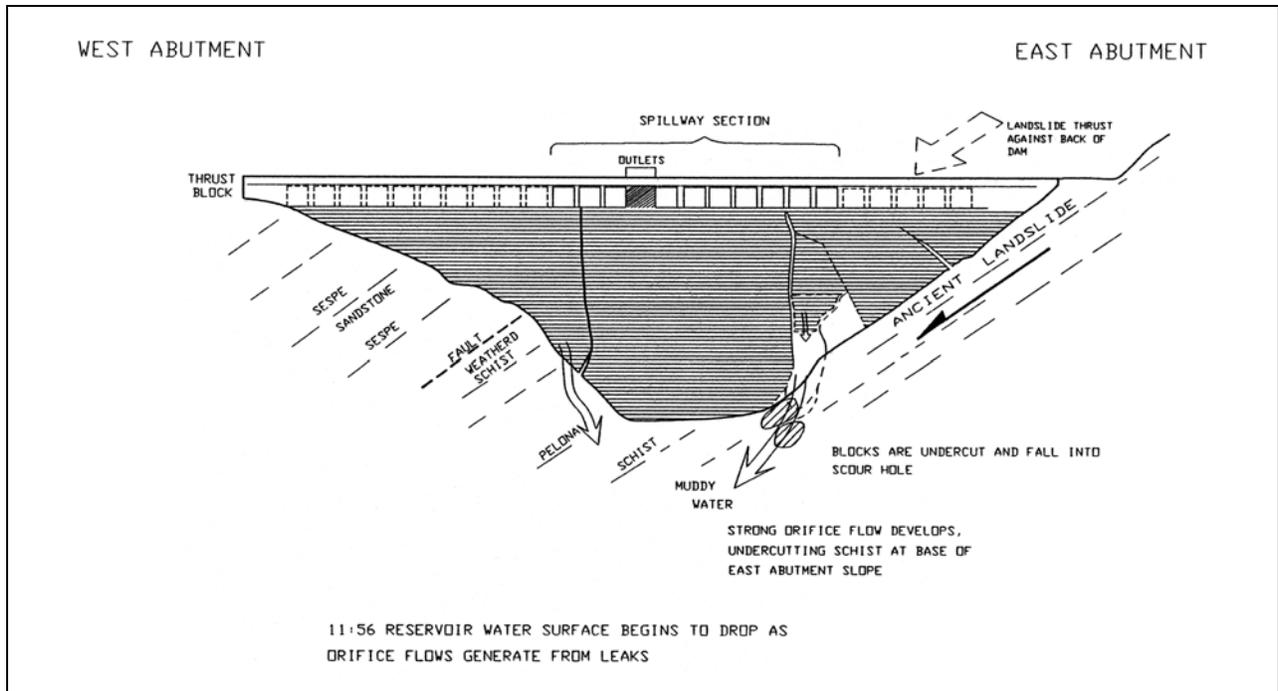
Figure 49. Schematic elevation view hypothesizing a precursory leakage at the base of the dam’s left abutment. The body of the damkeeper’s wife was later found at the base of the structure, and pieces of the dam from this area were carried furthest downstream.

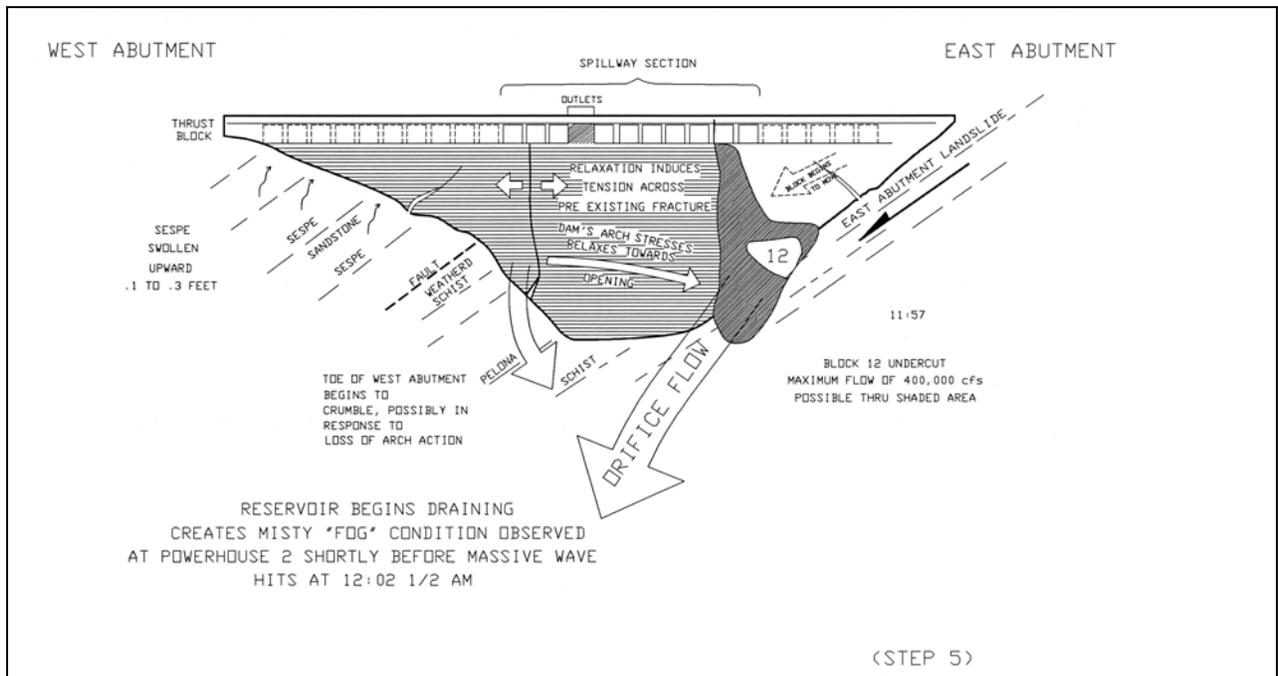
Figure 50. As the east abutment landslide mobilizes, Block 12 at base of the left abutment’s “missing section” is separated from the dam. Orifice flow at base of the left abutment slide may have created misty fog condition described by one of the Powerhouse 2 survivors.

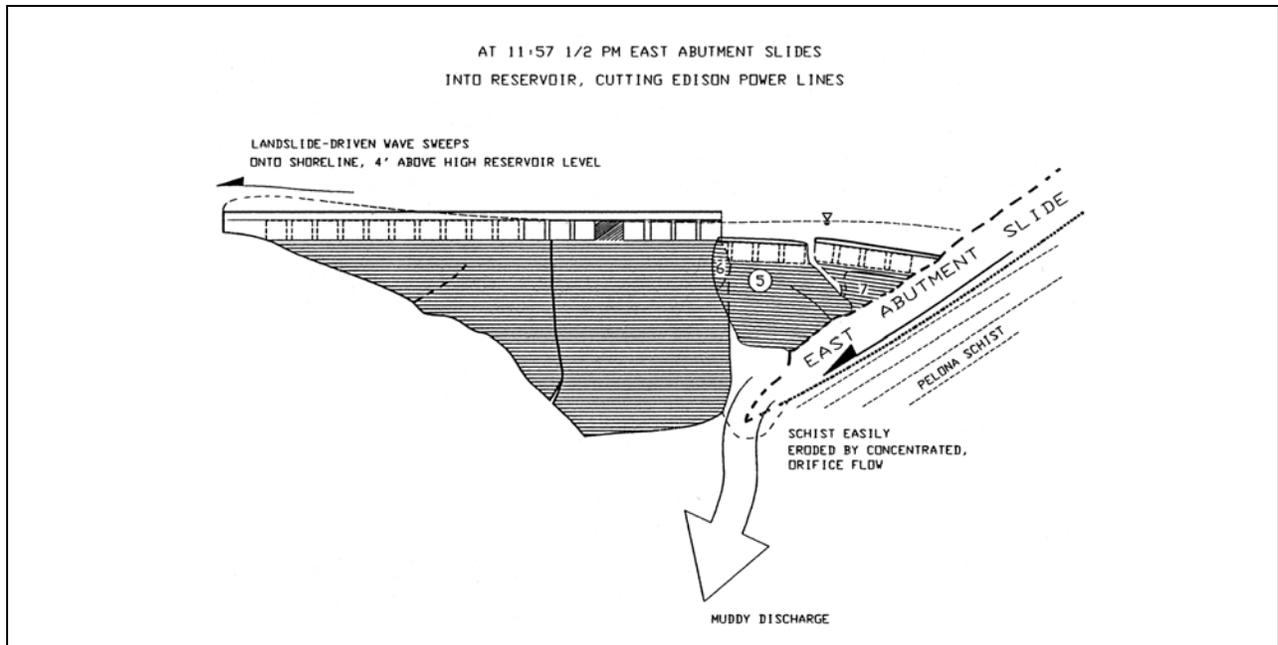
Figure 51. Schematic portrayal of the initial mobilization of the east abutment landslide, which severed power lines 90 feet above the dam crest on this abutment at 11:57-1/2 PM. A pile of flotsam was discovered the day after the failure washed 4 feet above the maximum pool level on the northwest shore of the former reservoir.

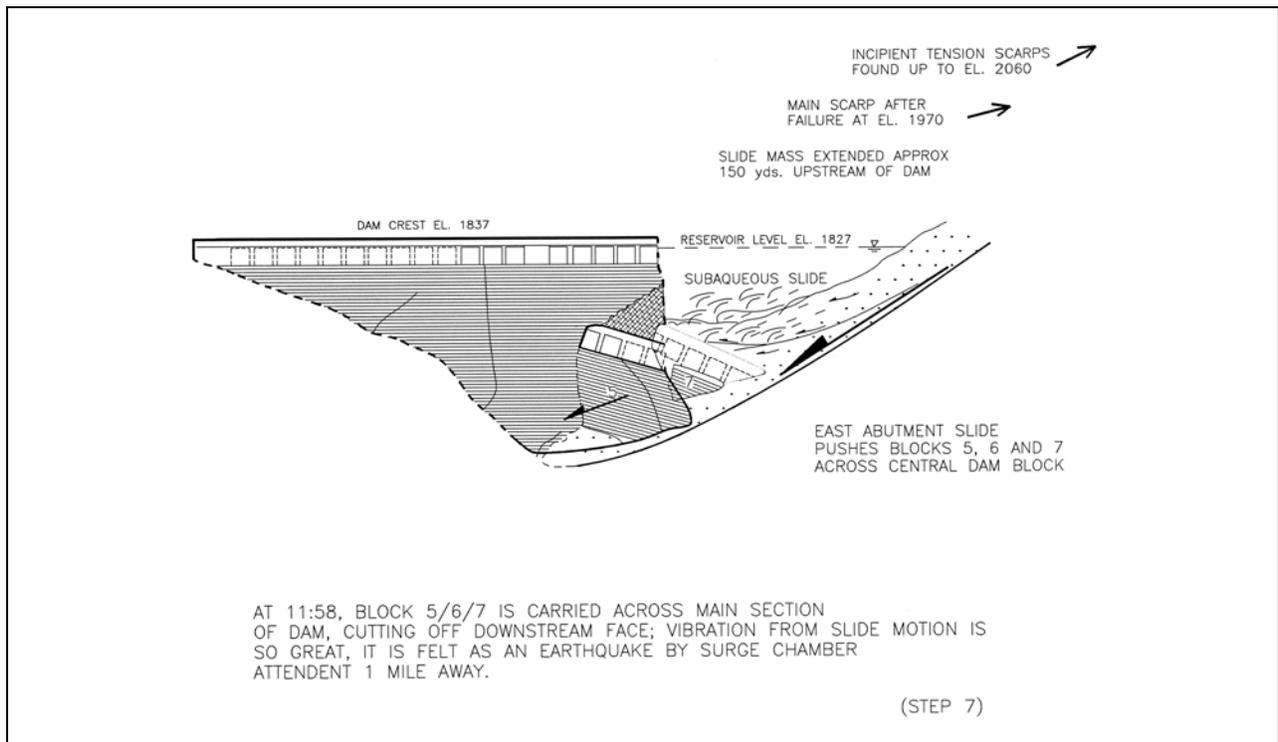
Figure 52. Schematic portrayal of the east abutment slide carrying Blocks 5/6/7 across the downstream face of the central dam core, shearing off about 10 feet of the dam's concrete on the stepped downstream face.

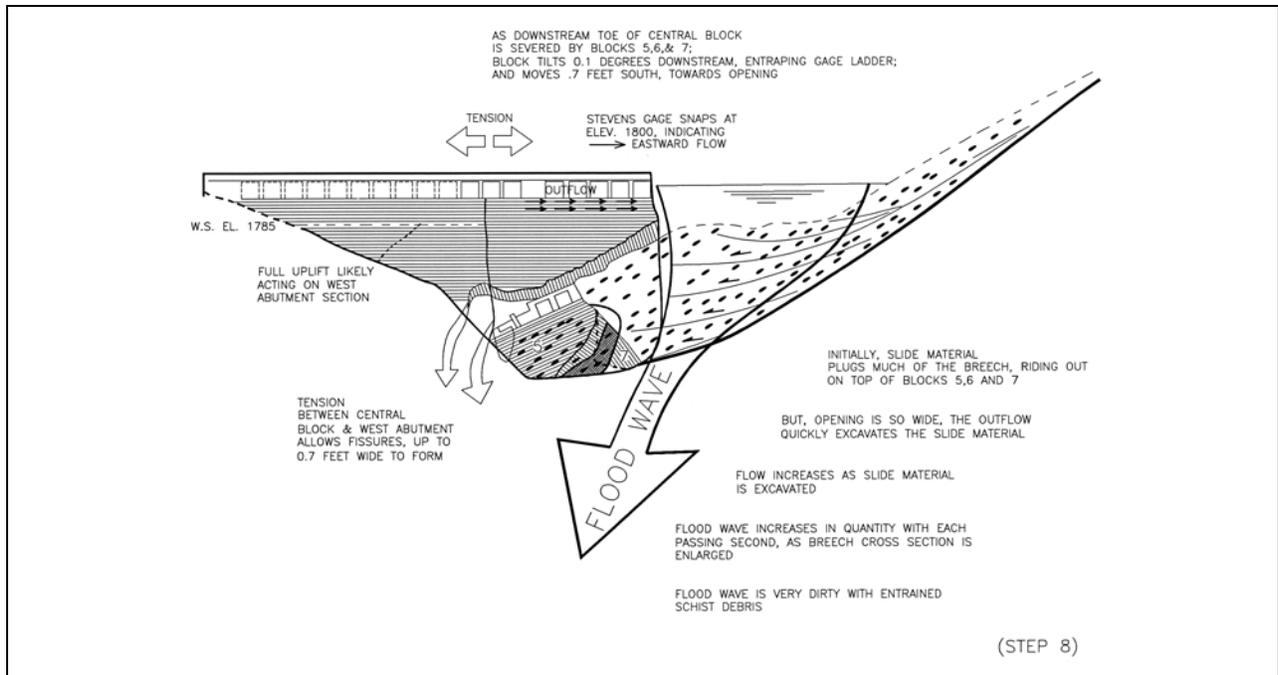
Figure 53. Schematic portrayal of the removal of the landslide debris dam created by the sudden mass movement of the east abutment slide, as a sort of quasi-subaqueous flow. The debris was a short-lived impedance to the outpouring waters. Note that Block 5 originally came to rest at a higher elevation, as noted by the chatter marks on Blocks 1 and 16.
